Intersection ID: 22502	Main Street: SHARON_VIEW_RD	Cross Street: OLD_PROVIDENCE_RD	Location:	SW
ADA ID: 5B59F8773FA2	Ramp Type: Perp	Initial Pass/Fail: Fail	Overall Compliance: No	Severity Score: 50

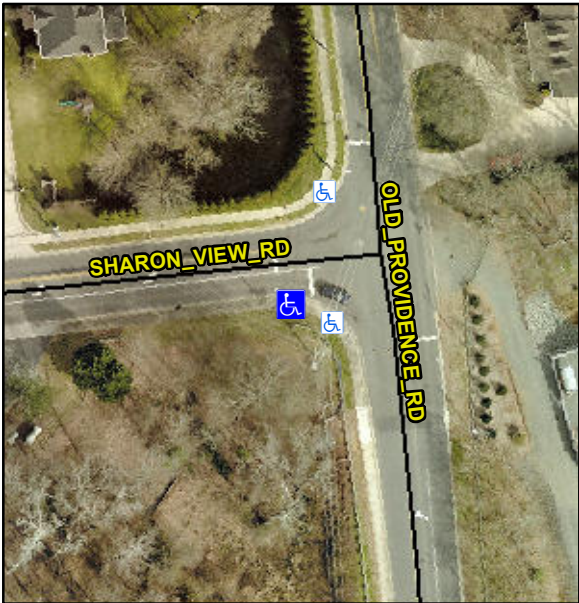
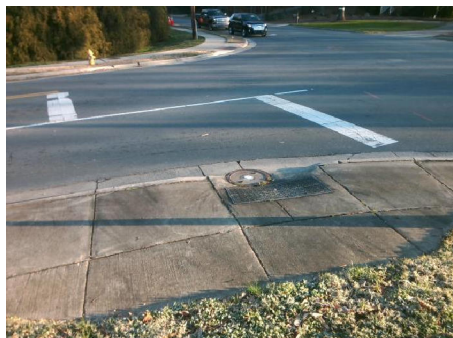
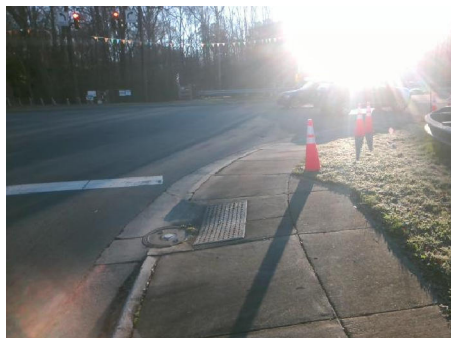
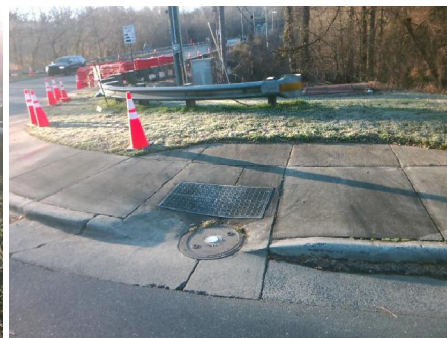
Possible Solutions:		Compliance	Description	Data	Compliance	Description	Data
	Remove & Replace Entire Ramp.		N/A	Ramp Length (in)	60.5	No	Ramp Slope (%)	18.6
			Yes	Ramp Width (in)	48.0	No	Ramp XSlope (%)	11.9
			N/A	Flare Type LT	N/A	N/A	Flare Type RT	N/A
			N/A	Flare Slope LT (%)	N/A	N/A	Flare Slope RT (%)	N/A
			N/A	Flare Traversable LT?	N/A	N/A	Flare Traversable RT?	N/A
			N/A	Landing Length (in)	N/A	N/A	DWS Provided?	N/A
			N/A	Landing Width (in)	N/A	N/A	DWS Contrast?	N/A
			N/A	Landing Slope (%)	N/A	N/A	DWS Length (in)	N/A
			N/A	Landing X Slope (%)	N/A	N/A	DWS Full Width?	N/A
Surveyor Notes:		N/A	N/A	Landing Curb? (Y/N)	N/A	N/A	DWS Offset (in)	N/A
PROW/ADA:		Not Found, R304.2.2, R304.5.3	N/A	Shared Landing?	N/A	N/A	Gutter Slope (%)	N/A
			N/A	Gutter Ponding?	N/A	N/A	Gutter X Slope (%)	N/A
			N/A	Gutter Lip Ht (in)	N/A	N/A	Painted X Walk2?	N/A

N/A	Painted X Walk1?	No	N/A	X Walk 2 Direction	N/A
				X Walk 1 Direction	To N		X Walk 2 Width (in)	N/A
			N/A	X Walk 1 Width (in)	N/A	N/A	X Walk 2 Slope (%)	N/A
				X Walk 1 Slope (%)	4.1		X Walk 2 X Slope (%)	N/A
				X Walk 1 X Slope (%)	1.2		Ramp inside XWalk2?	N/A
			N/A	Ramp inside XWalk1?	N/A	N/A	Clear Space?	N/A
				Road Slope (%)	N/A	N/A	Clear Space to XWalk (in)	N/A
				Road X Slope (%)	N/A	N/A	Storm Grate/Utility Hazard?	N/A
			N/A	Any Obstructions?	N/A	N/A	Storm Grate/Utility Type	
				Obstruction Type				
					N/A			N/A
						Yes	Surface Condition? (G/P)	Good
Street 1 Name		SHARON VIEW RD						
Stop Condition-Street 2		Signal						
Street 2 Name		N/A						
Stop Condition-Street 1		N/A						
Total Cost:		\$ 1850.00
