Access Compliance Report

Public Rights-of-Way

(Curb Ramps)

Intersection ID: 10033982	Main Street: PARK_RD	Cross Street: N/A	Location: NE
ADA ID: 5B67365306EA	Ramp Type: BlendTrans2	Initial Pass/Fail: Fail	Overall Compliance: No
		Severity Score: 8.75

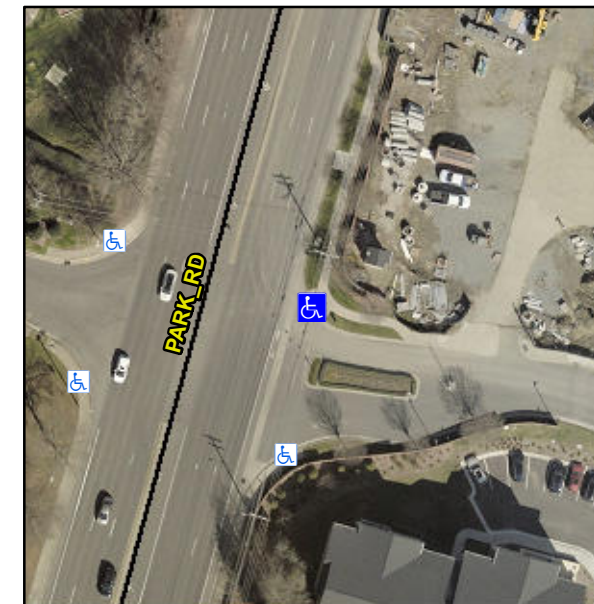
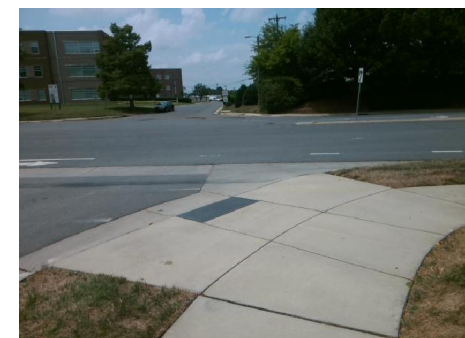
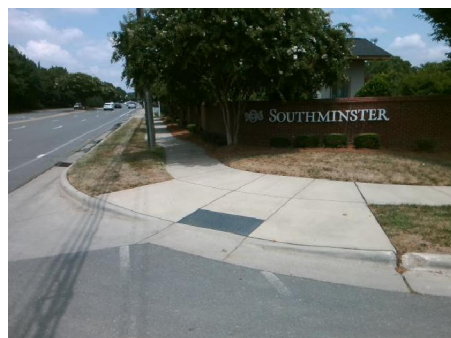
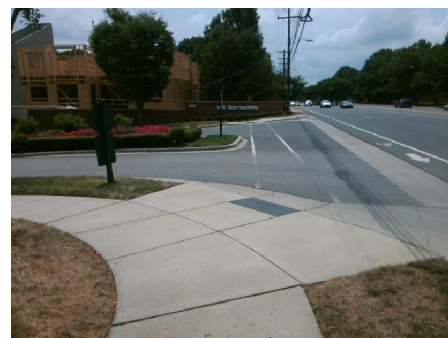
Not Found, R304.5.1

Compliance	Description	Data	Compliance	Description	Data
N/A	Ramp Length (in)	130.0	Yes	BlendTrans Slope (%)	4.3
No	Ramp Width (in)	46.0	Yes	BlendTrans XSlope (%)	1.6
N/A	Flare Type LT	N/A	N/A	Flare Type RT	N/A
N/A	Flare Slope LT (%)	N/A	N/A	Flare Slope RT (%)	N/A
N/A	Flare Traversable LT?	N/A	N/A	Flare Traversable RT?	N/A
N/A	Landing Length (in)	N/A	N/A	DWS Provided?	N/A
N/A	Landing Width (in)	N/A	N/A	DWS Contrast?	N/A
N/A	Landing Slope (%)	N/A	N/A	DWS Length (in)	N/A
N/A	Landing X Slope (%)	N/A	N/A	DWS Full Width?	N/A
N/A	Landing Curb? (Y/N)	N/A	N/A	DWS Offset (in)	N/A
N/A	Shared Landing?	N/A			
N/A	Gutter Ponding?	N/A	N/A	Gutter Slope (%)	N/A
N/A	Gutter Lip Ht (in)	N/A	N/A	Gutter X Slope (%)	N/A
N/A	Painted X Walk1?	No	N/A	Painted X Walk2?	Yes
	X Walk 1 Direction	To NW		X Walk 2 Direction	To S
	X Walk 1 Width (in)	N/A		X Walk 2 Width (in)	53.0
	X Walk 1 Slope (%)	2.1		X Walk 2 Slope (%)	0.2
	X Walk 1 X Slope (%)	1.8		X Walk 2 X Slope (%)	3.8

N/A	Ramp inside XWalk1?	N/A	N/A	Ramp inside XWalk2?	Yes
	Road Slope (%)	0.2		Clear Space?	N/A
	Road X Slope (%)	2.2	N/A	Clear Space to XWalk (in)	N/A
N/A	Any Obstructions?	N/A	N/A	Storm Grate/Utility Hazard?	N/A
	Obstruction Type			Storm Grate/Utility Type	
		N/A			N/A
			Yes	Surface Condition? (G/P)	Good
			No	Curb Slope (%)	13.6

Remove & Replace Curb Ramp With Two New Directional Ramps or Equivalent.

Total Cost: \$ 3200.00
