Access Compliance Report

Public Rights-of-Way (Curb Ramps)

Intersection ID: N/A	Main Street: W T HARRIS BV	Cross Street: N/A	Location: NW
ADA ID: 5B7897E04F6C	Ramp Type: PerpDiag	Initial Pass/Fail: Fail	Overall Compliance: No
		Severity Score: 12.5

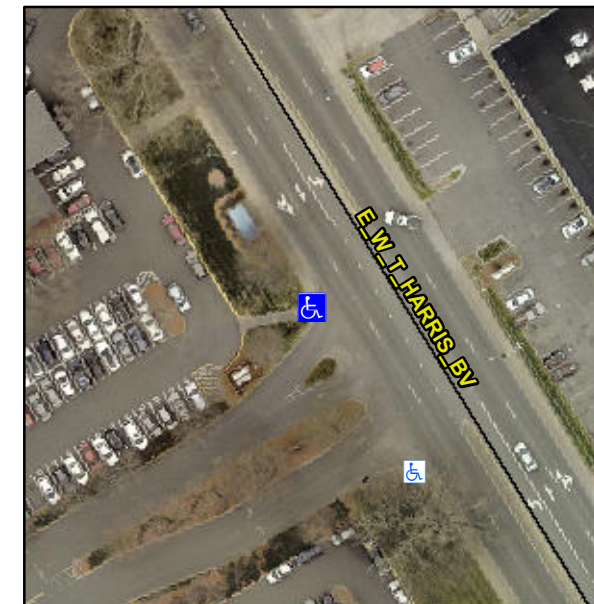
Not Found, R304.2.2

Compliance	Description	Data	Compliance	Description	Data
N/A	Ramp Length (in)	61.0	No	Ramp Slope (%)	11.2
Yes	Ramp Width (in)	76.0	Yes	Ramp XSlope (%)	0.8
N/A	Flare Type LT	N/A	N/A	Flare Type RT	N/A
N/A	Flare Slope LT (%)	N/A	N/A	Flare Slope RT (%)	N/A
N/A	Flare Traversable LT?	N/A	N/A	Flare Traversable RT?	N/A
N/A	Landing Length (in)	N/A	N/A	DWS Provided?	N/A
N/A	Landing Width (in)	N/A	N/A	DWS Contrast?	N/A
N/A	Landing Slope (%)	N/A	N/A	DWS Length (in)	N/A
N/A	Landing X Slope (%)	N/A	N/A	DWS Full Width?	N/A
N/A	Landing Curb? (Y/N)	N/A	N/A	DWS Offset (in)	N/A
N/A	Shared Landing?	N/A			
N/A	Gutter Ponding?	N/A	N/A	Gutter Slope (%)	N/A
N/A	Gutter Lip Ht (in)	N/A	N/A	Gutter X Slope (%)	N/A
N/A	Painted X Walk1?	No	N/A	Painted X Walk2?	No
	X Walk 1 Direction	To S		X Walk 2 Direction	To E
N/A	X Walk 1 Width (in)	N/A	N/A	X Walk 2 Width (in)	N/A
	X Walk 1 Slope (%)	1.6		X Walk 2 Slope (%)	1.4
	X Walk 1 X Slope (%)	1.7		X Walk 2 X Slope (%)	1.1

N/A	Ramp inside XWalk1?	N/A	N/A	Ramp inside XWalk2?	N/A
	Road Slope (%)	0.7	N/A	Clear Space?	N/A
	Road X Slope (%)	1.2	N/A	Clear Space to XWalk (in)	N/A
N/A	Any Obstructions?	N/A	N/A	Storm Grate/Utility Hazard?	N/A
	Obstruction Type			Storm Grate/Utility Type	
		N/A			N/A
			Yes	Surface Condition? (G/P)	Good

Remove & Replace Curb Ramp With Two New Directional Ramps or Equivalent.

Total Cost: \$ 3200.00
