Access Compliance Report

Public Rights-of-Way (Curb Ramps)

Intersection ID: 53425	Main Street: HOUSTON_FIELD_CT	Cross Street: PROVIDENCE_RD	Location: NE
ADA ID: 5B7BD50F42F6	Ramp Type: Perp	Initial Pass/Fail: Fail	Overall Compliance: No
Severity Score: 21.25			
Codes/Mitigation Info/Possible Solution		Field Measurements/Component Compliance

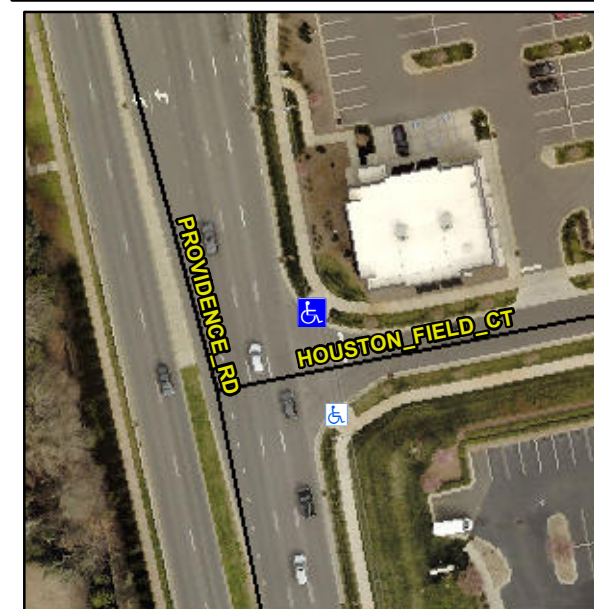
Not Found, R304.5.1, R304.2.2

Compliance	Description	Data	Compliance	Description	Data
N/A	Ramp Length (in)	96.5	No	Ramp Slope (%)	8.6
No	Ramp Width (in)	47.5	Yes	Ramp XSlope (%)	0.7
N/A	Flare Type LT	N/A	N/A	Flare Type RT	N/A
N/A	Flare Slope LT (%)	N/A	N/A	Flare Slope RT (%)	N/A
N/A	Flare Traversable LT?	N/A	N/A	Flare Traversable RT?	N/A
N/A	Landing Length (in)	N/A	N/A	DWS Provided?	N/A
N/A	Landing Width (in)	N/A	N/A	DWS Contrast?	N/A
N/A	Landing Slope (%)	N/A	N/A	DWS Length (in)	N/A
N/A	Landing X Slope (%)	N/A	N/A	DWS Full Width?	N/A
N/A	Landing Curb? (Y/N)	N/A	N/A	DWS Offset (in)	N/A
N/A	Shared Landing?	N/A			
N/A	Gutter Ponding?	N/A	N/A	Gutter Slope (%)	N/A
N/A	Gutter Lip Ht (in)	N/A	N/A	Gutter X Slope (%)	N/A
N/A	Painted X Walk1?	No	N/A	Painted X Walk2?	N/A
	X Walk 1 Direction	To S		X Walk 2 Direction	N/A
N/A	X Walk 1 Width (in)	N/A	N/A	X Walk 2 Width (in)	N/A
	X Walk 1 Slope (%)	2.7		X Walk 2 Slope (%)	N/A
	X Walk 1 X Slope (%)	0.4		X Walk 2 X Slope (%)	N/A

N/A	Ramp inside XWalk1?	N/A	N/A	Ramp inside XWalk2?	N/A
	Road Slope (%)	N/A	N/A	Clear Space?	N/A
	Road X Slope (%)	N/A	N/A	Clear Space to XWalk (in)	N/A
N/A	Any Obstructions?	N/A	N/A	Storm Grate/Utility Hazard?	N/A
	Obstruction Type			Storm Grate/Utility Type	
		N/A			N/A
			Yes	Surface Condition? (G/P)	Good

Remove & Replace Entire Ramp.

Total Cost: \$ 1850.00
