Access Compliance Report

Public Rights-of-Way

(Curb Ramps)

Intersection ID: 5421	Main Street: SUNSET_RD	Cross Street: OLD_STATESVILLE_RD	Location: E
ADA ID: 5B7C2B647E97	Ramp Type: Perp	Initial Pass/Fail: Fail	Overall Compliance: No
		Severity Score: 35

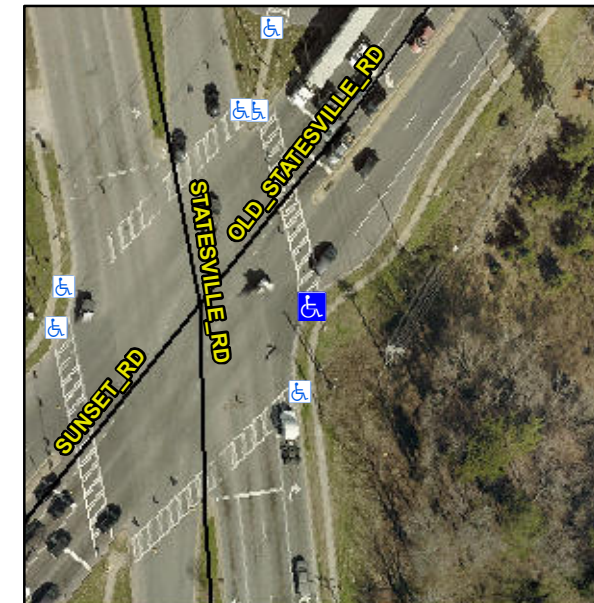
Compliance	Description	Data	Compliance	Description	Data
N/A	Ramp Length (in)	60.0	No	Ramp Slope (%)	12.1
No	Ramp Width (in)	40.0	No	Ramp XSlope (%)	2.6
N/A	Flare Type LT	N/A	N/A	Flare Type RT	N/A
N/A	Flare Slope LT (%)	N/A	N/A	Flare Slope RT (%)	N/A
N/A	Flare Traversable LT?	N/A	N/A	Flare Traversable RT?	N/A
N/A	Landing Length (in)	N/A	N/A	DWS Provided?	N/A
N/A	Landing Width (in)	N/A	N/A	DWS Contrast?	N/A
N/A	Landing Slope (%)	N/A	N/A	DWS Length (in)	N/A
N/A	Landing X Slope (%)	N/A	N/A	DWS Full Width?	N/A
N/A	Landing Curb? (Y/N)	N/A	N/A	DWS Offset (in)	N/A
N/A	Shared Landing?	N/A			
N/A	Gutter Ponding?	N/A	N/A	Gutter Slope (%)	N/A
N/A	Gutter Lip Ht (in)	N/A	N/A	Gutter X Slope (%)	N/A
N/A	Painted X Walk1?	Yes	N/A	Painted X Walk2?	N/A
	X Walk 1 Direction	To NW		X Walk 2 Direction	N/A
N/A	X Walk 1 Width (in)	137.0	N/A	X Walk 2 Width (in)	N/A
	X Walk 1 Slope (%)	1.2		X Walk 2 Slope (%)	N/A
	X Walk 1 X Slope (%)	2.5		X Walk 2 X Slope (%)	N/A

N/A	Ramp inside XWalk1?	Yes	N/A	Ramp inside XWalk2?	N/A
	Road Slope (%)	N/A	N/A	Clear Space?	N/A
	Road X Slope (%)	N/A	N/A	Clear Space to XWalk (in)	N/A
N/A	Any Obstructions?	N/A	N/A	Storm Grate/Utility Hazard?	N/A
	Obstruction Type			Storm Grate/Utility Type	
		N/A			N/A
			Yes	Surface Condition? (G/P)	Good

Remove & Replace Entire Ramp.
