Access Compliance Report

Public Rights-of-Way

(Curb Ramps)

Intersection ID: 10040624	Main Street: W_HEBRON_ST	Cross Street: N/A	Location: SE
ADA ID: 5B7CDB9BD5EE	Ramp Type: Directional1	Initial Pass/Fail: Fail	Overall Compliance: No
Severity Score: 12.5			
Codes/Mitigation Info/Possible Solution		Field Measurements/Component Compliance

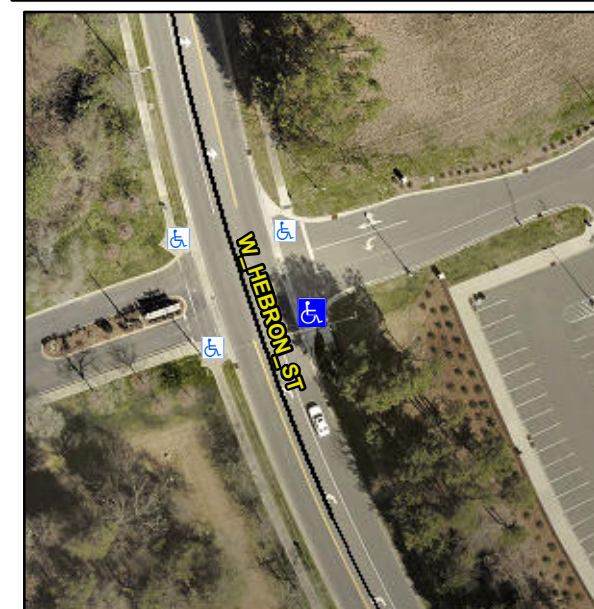
R304.5.3

Compliance	Description	Data	Compliance	Description	Data
N/A	Ramp Length (in)	58.0	N/A	Grade Break?	N/A
Yes	Ramp Width (in)	58.0	N/A	Grade Break Slope (%)	0.0
Yes	Ramp Slope (%)	7.4	N/A	Grade Break XSlope (%)	0.0
No	Ramp XSlope (%)	5.8			
N/A	Flare Type LT	N/A	N/A	Flare Type RT	N/A
N/A	Flare Slope LT (%)	N/A	N/A	Flare Slope RT (%)	0.0
N/A	Flare Traversable LT?	N/A	N/A	Flare Traversable RT?	N/A
N/A	Landing Length (in)	0.0	N/A	DWS Provided?	N/A
N/A	Landing Width (in)	0.0	N/A	DWS Contrast?	N/A
N/A	Landing Slope (%)	0.0	N/A	DWS Length (in)	N/A
N/A	Landing X Slope (%)	0.0	N/A	DWS Full Width?	N/A
N/A	Landing Curb? (Y/N)	N/A	N/A	DWS Offset LT (in)	N/A
N/A	Shared Landing?	N/A	N/A	DWS Offset RT (in)	N/A
N/A	Gutter Ponding?	0.0	N/A	Gutter Slope (%)	N/A
N/A	Gutter Lip Ht (in)	0.0	N/A	Gutter X Slope (%)	N/A
N/A	Painted X Walk1?	No		Road Slope (%)	1.2
	X Walk 1 Direction	To N		Road X Slope (%)	4.5
	X Walk 1 Width (in)	N/A		Clear Space?	N/A

X Walk 1 Slope (%)	1.2	N/A	Clear Space to XWalk (in)	N/A
	X Walk 1 X Slope (%)	4.5	N/A	Storm Grate/Utility Hazard?	N/A
N/A	Ramp inside XWalk1?	N/A		Storm Grate/Utility Type	
N/A	Any Obstructions?	N/A			N/A
	Obstruction Type		Yes	Surface Condition? (G/P)	Good
			N/A	Curb Slope (%)	7.2

Remove & Replace Entire Ramp.
