# Access Compliance Report

## Public Rights-of-Way

### (Curb Ramps)

Intersection ID: 50541	Main Street: CAYENNE_DR	Cross Street: LEMONGRASS_LN	Location: SE
ADA ID: 5B937A846730	Ramp Type: PerpDiag	Initial Pass/Fail: Fail	Overall Compliance: No
		Severity Score: 25

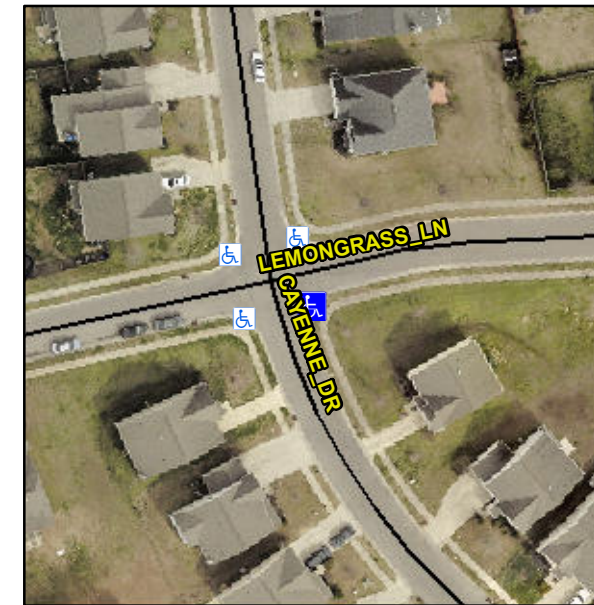
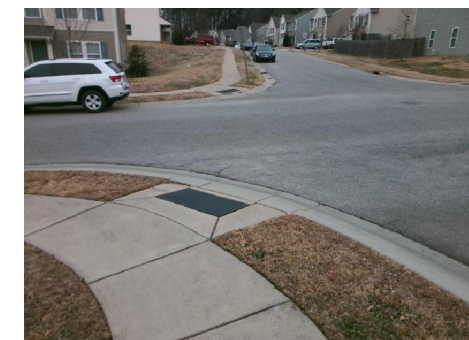
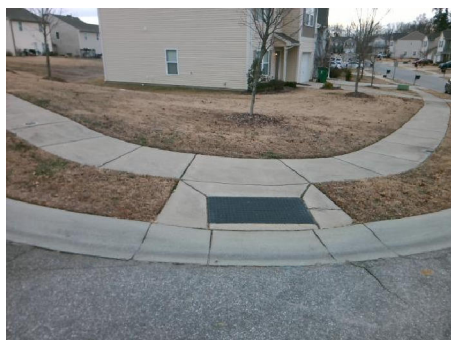
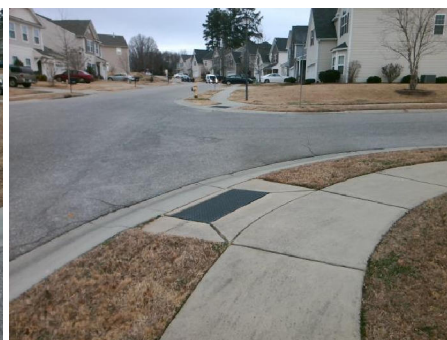
**Not Found, R304.2.2, R304.5.3**

Compliance	Description	Data	Compliance	Description	Data
N/A	Ramp Length (in)	48.5	No	Ramp Slope (%)	9.0
Yes	Ramp Width (in)	48.0	No	Ramp XSlope (%)	5.8
N/A	Flare Type LT	N/A	N/A	Flare Type RT	N/A
N/A	Flare Slope LT (%)	N/A	N/A	Flare Slope RT (%)	N/A
N/A	Flare Traversable LT?	N/A	N/A	Flare Traversable RT?	N/A
N/A	Landing Length (in)	N/A	N/A	DWS Provided?	N/A
N/A	Landing Width (in)	N/A	N/A	DWS Contrast?	N/A
N/A	Landing Slope (%)	N/A	N/A	DWS Length (in)	N/A
N/A	Landing X Slope (%)	N/A	N/A	DWS Full Width?	N/A
N/A	Landing Curb? (Y/N)	N/A	N/A	DWS Offset (in)	N/A
N/A	Shared Landing?	N/A			
N/A	Gutter Ponding?	N/A	N/A	Gutter Slope (%)	N/A
N/A	Gutter Lip Ht (in)	N/A	N/A	Gutter X Slope (%)	N/A
N/A	Painted X Walk1?	No	N/A	Painted X Walk2?	No
	X Walk 1 Direction	To N		X Walk 2 Direction	To W
N/A	X Walk 1 Width (in)	N/A	N/A	X Walk 2 Width (in)	N/A
	X Walk 1 Slope (%)	10.0		X Walk 2 Slope (%)	3.6
	X Walk 1 X Slope (%)	3.0		X Walk 2 X Slope (%)	6.8

N/A	Ramp inside XWalk1?	N/A	N/A	Ramp inside XWalk2?	N/A
	Road Slope (%)	4.2	N/A	Clear Space?	N/A
	Road X Slope (%)	6.8	N/A	Clear Space to XWalk (in)	N/A
N/A	Any Obstructions?	N/A	N/A	Storm Grate/Utility Hazard?	N/A
	Obstruction Type			Storm Grate/Utility Type	
		N/A			N/A
			Yes	Surface Condition? (G/P)	Good

**Remove & Replace Curb Ramp With Two New Directional Ramps or Equivalent.**
