# Access Compliance Report

## Public Rights-of-Way

### (Curb Ramps)

Intersection ID: 43159	Main Street: ARCHING_OAK_LN	Cross Street: N_SHARON_AMITY_RD	Location: S
ADA ID: 5B9510C16781	Ramp Type: ParaDiag	Initial Pass/Fail: Fail	Overall Compliance: No
Codes/Mitigation Info/Possible Solution		Field Measurements/Component Compliance

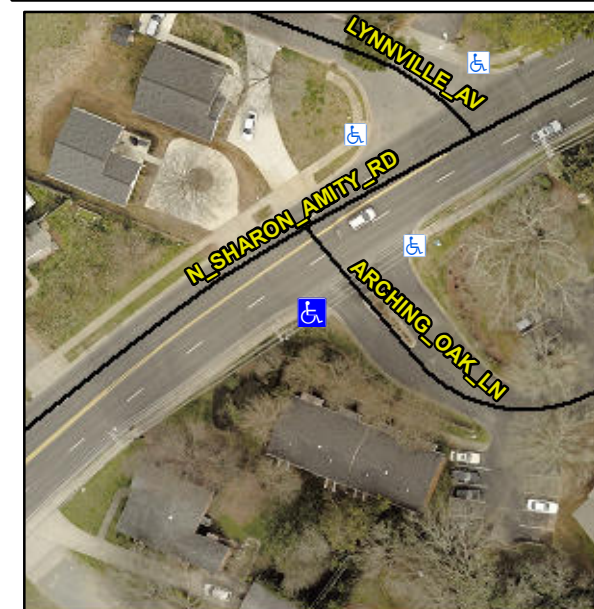
**LT RP < 5%**

**R304.5.3, R304.3.2**

Compliance	Description	Data	Compliance	Description	Data
N/A	Ramp Length LT (in)	57.0	N/A	Ramp Length RT (in)	61.0
Yes	Ramp Width LT (in)	60.0	Yes	Ramp Width RT (in)	62.0
Yes	Ramp Slope LT (%)	3.5	No	Ramp Slope RT (%)	10.6
No	Ramp XSlope LT (%)	3.0	No	Ramp XSlope RT (%)	3.9
N/A	Landing Length (in)	N/A	N/A	DWS Provided?	N/A
N/A	Landing Width (in)	N/A	N/A	DWS Contrast?	N/A
N/A	Landing Slope (%)	N/A	N/A	DWS Length (in)	N/A
N/A	Landing X Slope (%)	N/A	N/A	DWS Full Width?	N/A
N/A	Landing Curb? (Y/N)	N/A	N/A	DWS Offset (in)	N/A
N/A	Shared Landing?	N/A			
N/A	Gutter Ponding?	N/A	N/A	Gutter Slope (%)	N/A
N/A	Gutter Lip Ht (in)	N/A	N/A	Gutter X Slope (%)	N/A
N/A	Painted X Walk1?	No	N/A	Painted X Walk2?	No
	X Walk 1 Direction	To NE		X Walk 2 Direction	To NW
N/A	X Walk 1 Width (in)	N/A	N/A	X Walk 2 Width (in)	N/A
	X Walk 1 Slope (%)	0.7		X Walk 2 Slope (%)	6.4
	X Walk 1 X Slope (%)	3.4		X Walk 2 X Slope (%)	0.6
N/A	Ramp inside XWalk1?	N/A	N/A	Ramp inside XWalk2?	N/A

**Remove & Replace Curb Ramp With Two New Directional Ramps or Equivalent.**
