## Access Compliance Report Public Rights-of-Way (Curb Ramps)

Intersection ID: 44272 Main Street: TRAVIS\_FLOYD\_LN Cross Street: DANIEL\_DWAYNE\_DR Location: N

ADA ID: 5B99D0B54098 Ramp Type: PerpDiag Initial Pass/Fail: Fail Overall Compliance: No Severity Score: 22.5

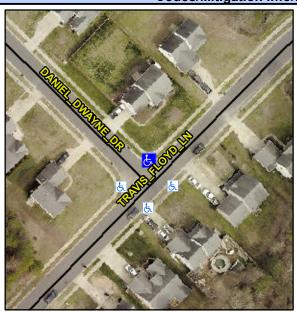
Not Found, R304.5.1, R304.2.2, R304.5.3

Field Measurements/Component Compliance						
	Compliance Description		Data	Comp	liance Description	Data
	N/A	Ramp Length (in)	46.0	No	Ramp Slope (%)	10.0
	No	Ramp Width (in)	36.0	No	Ramp XSlope (%)	2.8
	N/A	Flare Type LT	N/A	N/A	Flare Type RT	N/A
	N/A	Flare Slope LT (%)	N/A	N/A	Flare Slope RT (%)	N/A
	N/A	Flare Traversable LT?	N/A	N/A	Flare Traversable RT?	N/A
	N/A	Landing Length (in)	N/A	N/A	DWS Provided?	N/A
	N/A	Landing Width (in)	N/A	N/A	DWS Contrast?	N/A
	N/A	Landing Slope (%)	N/A	N/A	DWS Length (in)	N/A
	N/A	Landing X Slope (%)	N/A	N/A	DWS Full Width?	N/A
	N/A	Landing Curb? (Y/N)	N/A	N/A	DWS Offset (in)	N/A
	N/A	Shared Landing?	N/A			
	N/A	Gutter Ponding?	N/A	N/A	Gutter Slope (%)	N/A
	N/A	Gutter Lip Ht (in)	N/A	N/A	Gutter X Slope (%)	N/A
	N/A	Painted X Walk1?	No	N/A	Painted X Walk2?	No
		X Walk 1 Direction	To W		X Walk 2 Direction	To E
	N/A	X Walk 1 Width (in)	N/A	N/A	X Walk 2 Width (in)	N/A
		X Walk 1 Slope (%)	5.9		X Walk 2 Slope (%)	4.8

X Walk 1 X Slope (%)	1.8		X Walk 2 X Slope (%)	2.4
	N/A	Ramp inside XWalk1?	N/A	N/A	Ramp inside XWalk2?	N/A
		Road Slope (%)	1.5	N/A	Clear Space?	N/A
		Road X Slope (%)	3.3	N/A	Clear Space to XWalk (in)	N/A
	N/A	Any Obstructions?	N/A	N/A	Storm Grate/Utility Hazard?	N/A
		Obstruction Type			Storm Grate/Utility Type	
			N/A			N/A
				Yes	Surface Condition? (G/P)	Good
Dif.

Remove & Replace Curb Ramp With Two New Directional Ramps or Equivalent.
