# Access Compliance Report

## Public Rights-of-Way

Intersection ID: 16526	Main Street: AMITY_PL	Cross Street: ASPENDALE_LN	Location: SE
ADA ID: 5BA60114C69A	Ramp Type: PerpDiag	Initial Pass/Fail: Fail	Overall Compliance: No
Severity Score: 33.75

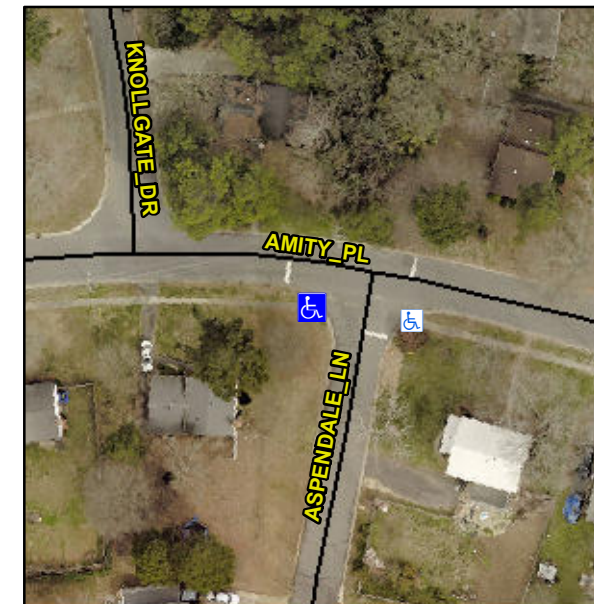
**Not Found, R304.5.1, R304.5.3**

Compliance	Description	Data	Compliance	Description	Data
N/A	Ramp Length (in)	52.0	Yes	Ramp Slope (%)	7.9
No	Ramp Width (in)	45.0	No	Ramp XSlope (%)	8.4
N/A	Flare Type LT	N/A	N/A	Flare Type RT	N/A
N/A	Flare Slope LT (%)	N/A	N/A	Flare Slope RT (%)	N/A
N/A	Flare Traversable LT?	N/A	N/A	Flare Traversable RT?	N/A
N/A	Landing Length (in)	N/A	N/A	DWS Provided?	N/A
N/A	Landing Width (in)	N/A	N/A	DWS Contrast?	N/A
N/A	Landing Slope (%)	N/A	N/A	DWS Length (in)	N/A
N/A	Landing X Slope (%)	N/A	N/A	DWS Full Width?	N/A
N/A	Landing Curb? (Y/N)	N/A	N/A	DWS Offset (in)	N/A
N/A	Shared Landing?	N/A			
N/A	Gutter Ponding?	N/A	N/A	Gutter Slope (%)	N/A
N/A	Gutter Lip Ht (in)	N/A	N/A	Gutter X Slope (%)	N/A
N/A	Painted X Walk1?	No	N/A	Painted X Walk2?	No
	X Walk 1 Direction	To E		X Walk 2 Direction	To N
N/A	X Walk 1 Width (in)	N/A	N/A	X Walk 2 Width (in)	N/A
	X Walk 1 Slope (%)	0.2		X Walk 2 Slope (%)	6.4
	X Walk 1 X Slope (%)	5.3		X Walk 2 X Slope (%)	2.7

N/A	Ramp inside XWalk1?	N/A	N/A	Ramp inside XWalk2?	N/A
	Road Slope (%)	6.0	N/A	Clear Space?	N/A
	Road X Slope (%)	3.6	N/A	Clear Space to XWalk (in)	N/A
N/A	Any Obstructions?	N/A	N/A	Storm Grate/Utility Hazard?	N/A
	Obstruction Type			Storm Grate/Utility Type	
		N/A			N/A
		Yes		Surface Condition? (G/P)	Good

**Remove & Replace Curb Ramp With Two New Directional Ramps or Equivalent.**
