Access Compliance Report

Public Rights-of-Way

(Curb Ramps)

Intersection ID: 11717	Main Street: E_15TH_ST	Cross Street: N_DAVIDSON_ST	Location: N
ADA ID: 5BAF575F80E6	Ramp Type: PerpDiag	Initial Pass/Fail: Fail	Overall Compliance: No
Severity Score: 22.5			
Codes/Mitigation Info/Possible Solution		Field Measurements/Component Compliance

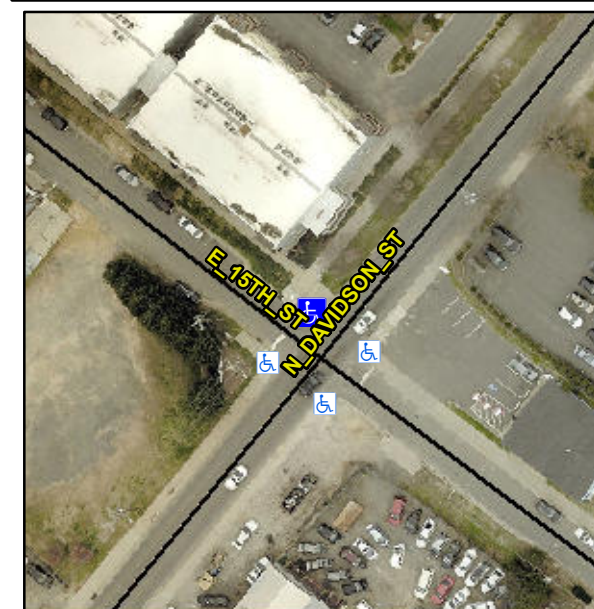
Compliance	Description	Data	Compliance	Description	Data
N/A	Ramp Length (in)	73.0	No	Ramp Slope (%)	11.0
No	Ramp Width (in)	47.5	No	Ramp XSlope (%)	4.4
N/A	Flare Type LT	N/A	N/A	Flare Type RT	N/A
N/A	Flare Slope LT (%)	N/A	N/A	Flare Slope RT (%)	N/A
N/A	Flare Traversable LT?	N/A	N/A	Flare Traversable RT?	N/A
N/A	Landing Length (in)	N/A	N/A	DWS Provided?	N/A
N/A	Landing Width (in)	N/A	N/A	DWS Contrast?	N/A
N/A	Landing Slope (%)	N/A	N/A	DWS Length (in)	N/A
N/A	Landing X Slope (%)	N/A	N/A	DWS Full Width?	N/A
N/A	Landing Curb? (Y/N)	N/A	N/A	DWS Offset (in)	N/A
N/A	Shared Landing?	N/A			
N/A	Gutter Ponding?	N/A	N/A	Gutter Slope (%)	N/A
N/A	Gutter Lip Ht (in)	N/A	N/A	Gutter X Slope (%)	N/A
N/A	Painted X Walk1?	No	N/A	Painted X Walk2?	No
	X Walk 1 Direction	To SW		X Walk 2 Direction	To SE
N/A	X Walk 1 Width (in)	N/A	N/A	X Walk 2 Width (in)	N/A
	X Walk 1 Slope (%)	3.5		X Walk 2 Slope (%)	3.6
	X Walk 1 X Slope (%)	3.8		X Walk 2 X Slope (%)	0.6

N/A	Ramp inside XWalk1?	N/A	N/A	Ramp inside XWalk2?	N/A
	Road Slope (%)	3.4	N/A	Clear Space?	N/A
	Road X Slope (%)	5.0	N/A	Clear Space to XWalk (in)	N/A
N/A	Any Obstructions?	N/A	N/A	Storm Grate/Utility Hazard?	N/A
	Obstruction Type			Storm Grate/Utility Type	
		N/A			N/A
			Yes	Surface Condition? (G/P)	Good

Possible Solutions:

Remove & Replace Curb Ramp With Two New Directional Ramps or Equivalent.

R304.5.1, R304.2.2, R304.5.3
