Access Compliance Report

Public Rights-of-Way

(Curb Ramps)

Intersection ID: 9278	Main Street: OAKLAWN_AV	Cross Street: BOOKER_AV	Location: SE
ADA ID: 5BB9312FA2E5	Ramp Type: Perp	Initial Pass/Fail: Fail	Overall Compliance: No
Severity Score: 35			
Codes/Mitigation Info/Possible Solution		Field Measurements/Component Compliance

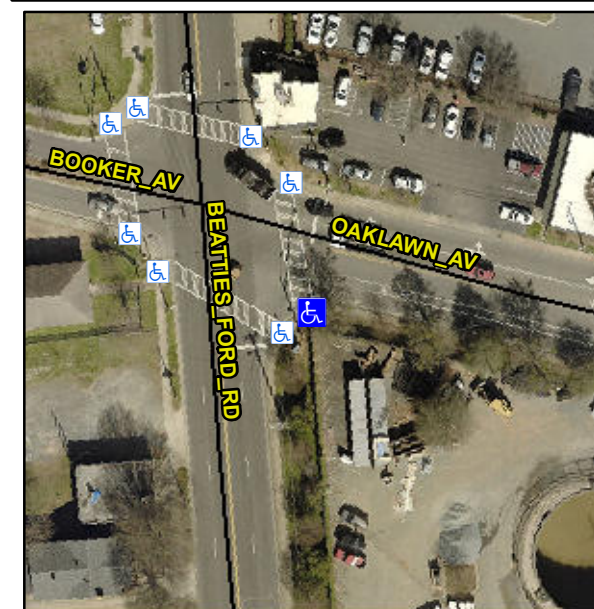
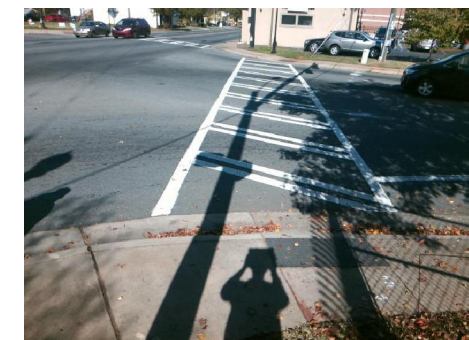
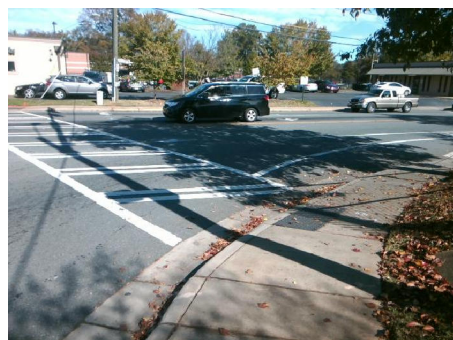
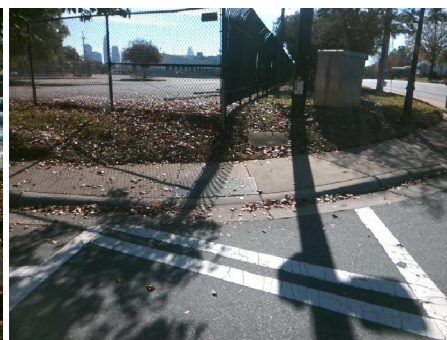
Not Found, R304.5.1, R304.2.2, R304.5.3

Compliance	Description	Data	Compliance	Description	Data
N/A	Ramp Length (in)	54.5	No	Ramp Slope (%)	12.4
No	Ramp Width (in)	42.0	No	Ramp XSlope (%)	4.7
N/A	Flare Type LT	N/A	N/A	Flare Type RT	N/A
N/A	Flare Slope LT (%)	N/A	N/A	Flare Slope RT (%)	N/A
N/A	Flare Traversable LT?	N/A	N/A	Flare Traversable RT?	N/A
N/A	Landing Length (in)	N/A	N/A	DWS Provided?	N/A
N/A	Landing Width (in)	N/A	N/A	DWS Contrast?	N/A
N/A	Landing Slope (%)	N/A	N/A	DWS Length (in)	N/A
N/A	Landing X Slope (%)	N/A	N/A	DWS Full Width?	N/A
N/A	Landing Curb? (Y/N)	N/A	N/A	DWS Offset (in)	N/A
N/A	Shared Landing?	N/A			
N/A	Gutter Ponding?	N/A	N/A	Gutter Slope (%)	N/A
N/A	Gutter Lip Ht (in)	N/A	N/A	Gutter X Slope (%)	N/A
N/A	Painted X Walk1?	Yes	N/A	Painted X Walk2?	N/A
	X Walk 1 Direction	To N		X Walk 2 Direction	N/A
N/A	X Walk 1 Width (in)	113.0	N/A	X Walk 2 Width (in)	N/A
	X Walk 1 Slope (%)	2.5		X Walk 2 Slope (%)	N/A
	X Walk 1 X Slope (%)	2.3		X Walk 2 X Slope (%)	N/A

N/A	Ramp inside XWalk1?	Yes	N/A	Ramp inside XWalk2?	N/A
	Road Slope (%)	N/A	N/A	Clear Space?	N/A
	Road X Slope (%)	N/A	N/A	Clear Space to XWalk (in)	N/A
N/A	Any Obstructions?	N/A	N/A	Storm Grate/Utility Hazard?	N/A
	Obstruction Type			Storm Grate/Utility Type	
		N/A			N/A
		Yes		Surface Condition? (G/P)	Good

Possible Solutions:

Remove & Replace Entire Ramp.
