Access Compliance Report

Public Rights-of-Way

(Curb Ramps)

Intersection ID: 52928	Main Street: GRAY_OAK_LN	Cross Street: MAPLE_OAK_DR	Location: NE
ADA ID: 5BC8C32AE62A	Ramp Type: BlendTrans1	Initial Pass/Fail: Fail	Overall Compliance: No
		Severity Score: 10

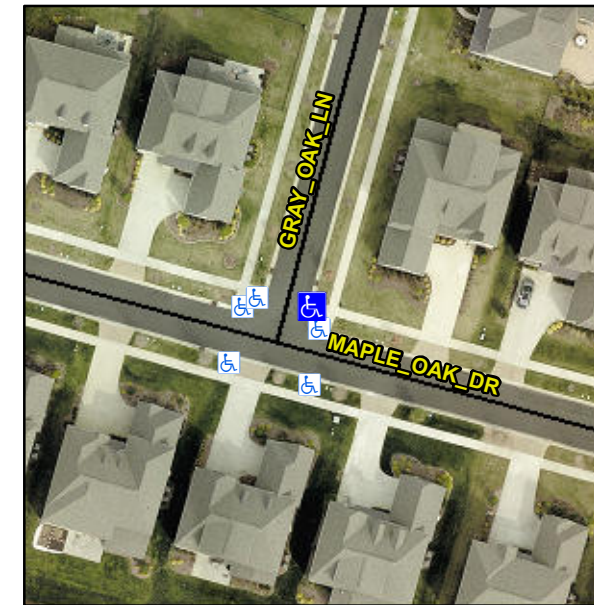
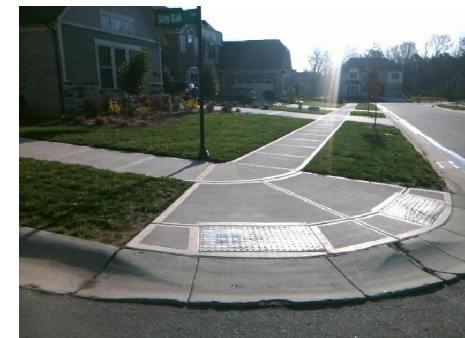
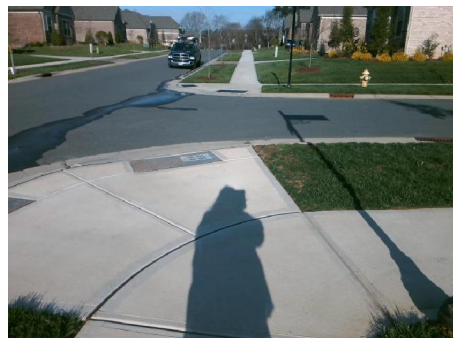
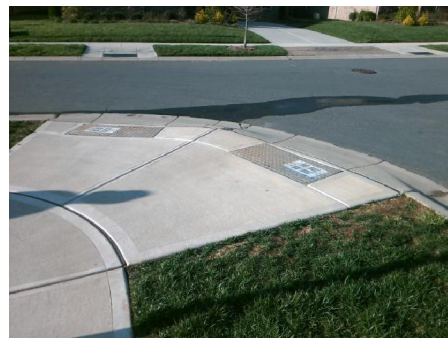
Not Found, R304.5.1, R304.5.3

Compliance	Description	Data	Compliance	Description	Data
N/A	Ramp Length (in)	28.0	Yes	BlendTrans Slope (%)	0.6
No	Ramp Width (in)	46.0	No	BlendTrans XSlope (%)	4.1
N/A	Flare Type LT	N/A	N/A	Flare Type RT	N/A
N/A	Flare Slope LT (%)	N/A	N/A	Flare Slope RT (%)	N/A
N/A	Flare Traversable LT?	N/A	N/A	Flare Traversable RT?	N/A
N/A	Landing Length (in)	N/A	N/A	DWS Provided?	N/A
N/A	Landing Width (in)	N/A	N/A	DWS Contrast?	N/A
N/A	Landing Slope (%)	N/A	N/A	DWS Length (in)	N/A
N/A	Landing X Slope (%)	N/A	N/A	DWS Full Width?	N/A
N/A	Landing Curb? (Y/N)	N/A	N/A	DWS Offset (in)	N/A
N/A	Shared Landing?	N/A			
N/A	Gutter Ponding?	N/A	N/A	Gutter Slope (%)	N/A
N/A	Gutter Lip Ht (in)	N/A	N/A	Gutter X Slope (%)	N/A
N/A	Painted X Walk1?	No	N/A	Painted X Walk2?	N/A
	X Walk 1 Direction	To W		X Walk 2 Direction	N/A
	X Walk 1 Width (in)	N/A		X Walk 2 Width (in)	N/A
	X Walk 1 Slope (%)	2.8		X Walk 2 Slope (%)	N/A
	X Walk 1 X Slope (%)	1.5		X Walk 2 X Slope (%)	N/A

N/A	Ramp inside XWalk1?	N/A	N/A	Ramp inside XWalk2?	N/A
	Road Slope (%)	1.5		Clear Space?	N/A
	Road X Slope (%)	2.8	N/A	Clear Space to XWalk (in)	N/A
N/A	Any Obstructions?	N/A	N/A	Storm Grate/Utility Hazard?	N/A
	Obstruction Type			Storm Grate/Utility Type	
		N/A			N/A
			Yes	Surface Condition? (G/P)	Good
			No	Curb Slope (%)	6.1

Remove & Replace Curb Ramp With Two New Directional Ramps or Equivalent.
