Access Compliance Report

Public Rights-of-Way

(Curb Ramps)

Intersection ID: 51441	Main Street: TAMARRON_DR	Cross Street: WOODLAND_WATCH_CT	Location: E
ADA ID: 5BCA9B64C9E6	Ramp Type: BlendTrans1	Initial Pass/Fail: Fail	Overall Compliance: No
Severity Score: 1.25			
Codes/Mitigation Info/Possible Solution		Field Measurements/Component Compliance

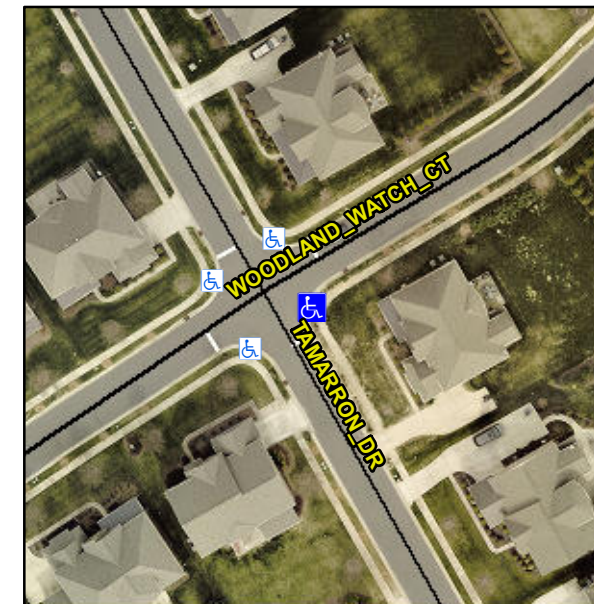
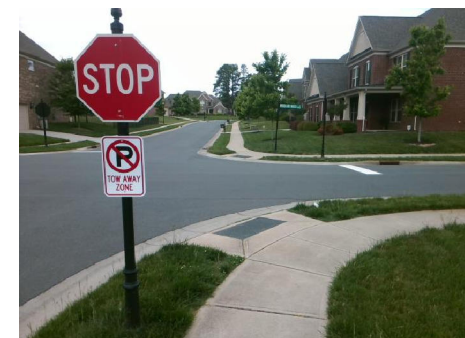
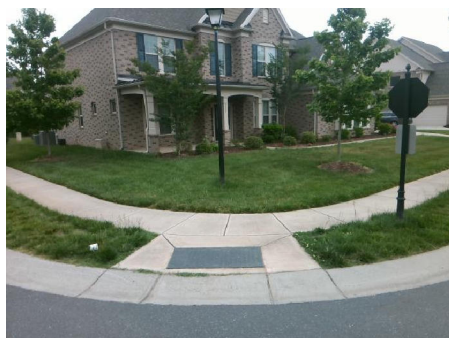
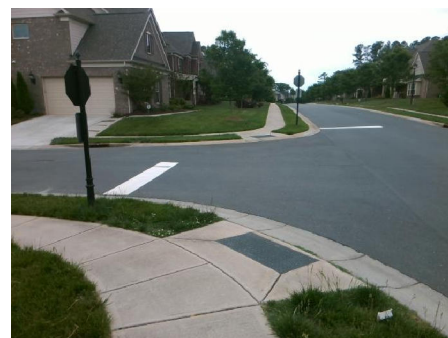
Not Found, R304.5.3

Compliance	Description	Data	Compliance	Description	Data
N/A	Ramp Length (in)	47.0	Yes	BlendTrans Slope (%)	4.6
Yes	Ramp Width (in)	48.0	No	BlendTrans XSlope (%)	2.2
N/A	Flare Type LT	N/A	N/A	Flare Type RT	N/A
N/A	Flare Slope LT (%)	N/A	N/A	Flare Slope RT (%)	N/A
N/A	Flare Traversable LT?	N/A	N/A	Flare Traversable RT?	N/A
N/A	Landing Length (in)	N/A	N/A	DWS Provided?	N/A
N/A	Landing Width (in)	N/A	N/A	DWS Contrast?	N/A
N/A	Landing Slope (%)	N/A	N/A	DWS Length (in)	N/A
N/A	Landing X Slope (%)	N/A	N/A	DWS Full Width?	N/A
N/A	Landing Curb? (Y/N)	N/A	N/A	DWS Offset (in)	N/A
N/A	Shared Landing?	N/A			
N/A	Gutter Ponding?	N/A	N/A	Gutter Slope (%)	N/A
N/A	Gutter Lip Ht (in)	N/A	N/A	Gutter X Slope (%)	N/A
N/A	Painted X Walk1?	No	N/A	Painted X Walk2?	No
	X Walk 1 Direction	To NW		X Walk 2 Direction	To SW
	X Walk 1 Width (in)	N/A		X Walk 2 Width (in)	N/A
	X Walk 1 Slope (%)	2.5		X Walk 2 Slope (%)	3.5
	X Walk 1 X Slope (%)	1.3		X Walk 2 X Slope (%)	2.4

N/A	Ramp inside XWalk1?	N/A	N/A	Ramp inside XWalk2?	N/A
	Road Slope (%)	0.6		Clear Space?	N/A
	Road X Slope (%)	3.9	N/A	Clear Space to XWalk (in)	N/A
N/A	Any Obstructions?	N/A	N/A	Storm Grate/Utility Hazard?	N/A
	Obstruction Type			Storm Grate/Utility Type	
		N/A			N/A
			Yes	Surface Condition? (G/P)	Good
			No	Curb Slope (%)	17.4

Remove & Replace Curb Ramp With Two New Directional Ramps or Equivalent.
