Access Compliance Report

Public Rights-of-Way

(Curb Ramps)

Intersection ID: 44447	Main Street: REAMES_RD	Cross Street: BAYVIEW_PY	Location:	E
ADA ID: 5BCFD31799B1	Ramp Type: BlendTrans1	Initial Pass/Fail: Fail	Overall Compliance: No	Severity Score: 10

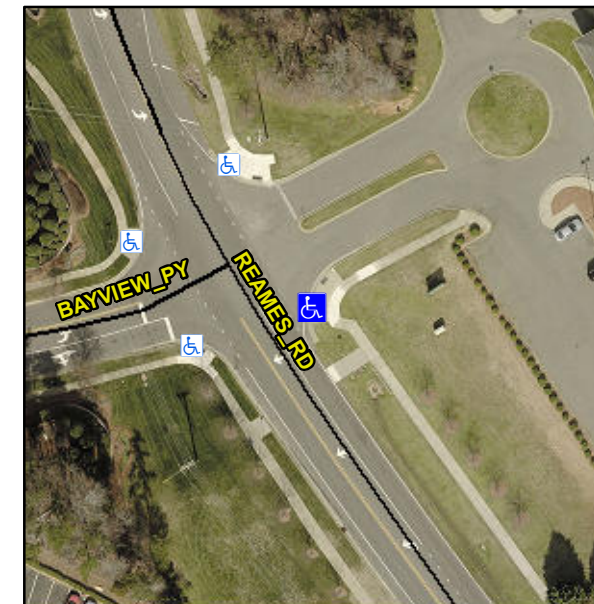
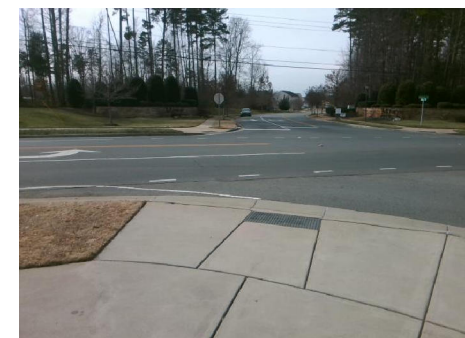
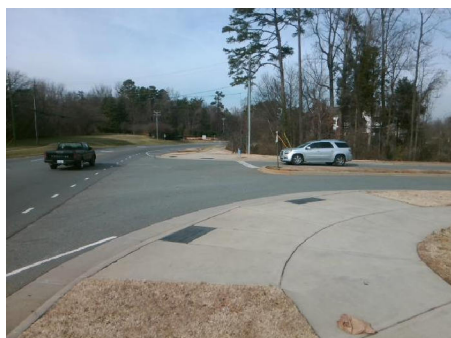
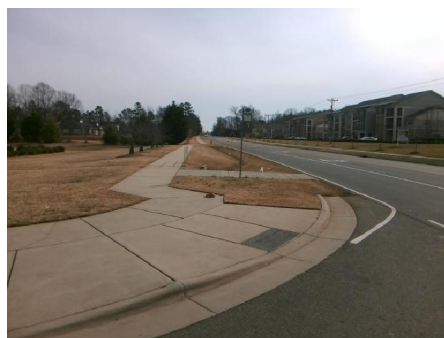
Not Found, R304.5.1, R304.5.3

Compliance	Description	Data	Compliance	Description	Data
N/A	Ramp Length (in)	99.0	Yes	BlendTrans Slope (%)	3.8
No	Ramp Width (in)	47.0	No	BlendTrans XSlope (%)	4.0
N/A	Flare Type LT	N/A	N/A	Flare Type RT	N/A
N/A	Flare Slope LT (%)	N/A	N/A	Flare Slope RT (%)	N/A
N/A	Flare Traversable LT?	N/A	N/A	Flare Traversable RT?	N/A
N/A	Landing Length (in)	N/A	N/A	DWS Provided?	N/A
N/A	Landing Width (in)	N/A	N/A	DWS Contrast?	N/A
N/A	Landing Slope (%)	N/A	N/A	DWS Length (in)	N/A
N/A	Landing X Slope (%)	N/A	N/A	DWS Full Width?	N/A
N/A	Landing Curb? (Y/N)	N/A	N/A	DWS Offset (in)	N/A
N/A	Shared Landing?	N/A			
N/A	Gutter Ponding?	N/A	N/A	Gutter Slope (%)	N/A
N/A	Gutter Lip Ht (in)	N/A	N/A	Gutter X Slope (%)	N/A
N/A	Painted X Walk1?	No	N/A	Painted X Walk2?	N/A
	X Walk 1 Direction	To S		X Walk 2 Direction	N/A
	X Walk 1 Width (in)	N/A		X Walk 2 Width (in)	N/A
	X Walk 1 Slope (%)	1.3		X Walk 2 Slope (%)	N/A
	X Walk 1 X Slope (%)	2.4		X Walk 2 X Slope (%)	N/A

N/A	Ramp inside XWalk1?	N/A	N/A	Ramp inside XWalk2?	N/A
	Road Slope (%)	2.4		Clear Space?	N/A
	Road X Slope (%)	1.3	N/A	Clear Space to XWalk (in)	N/A
N/A	Any Obstructions?	N/A	N/A	Storm Grate/Utility Hazard?	N/A
	Obstruction Type			Storm Grate/Utility Type	
		N/A			N/A
			Yes	Surface Condition? (G/P)	Good
			No	Curb Slope (%)	11.8

Remove & Replace Curb Ramp With Two New Directional Ramps or Equivalent.
