# Access Compliance Report

## Public Rights-of-Way

### (Curb Ramps)

Intersection ID: 10041074	Main Street: WATER_RIDGE_PY	Cross Street: N/A	Location: NW
ADA ID: 5BD3B8826EC6	Ramp Type: PerpDiag	Initial Pass/Fail: Fail	Overall Compliance: No
		Severity Score: 12.5

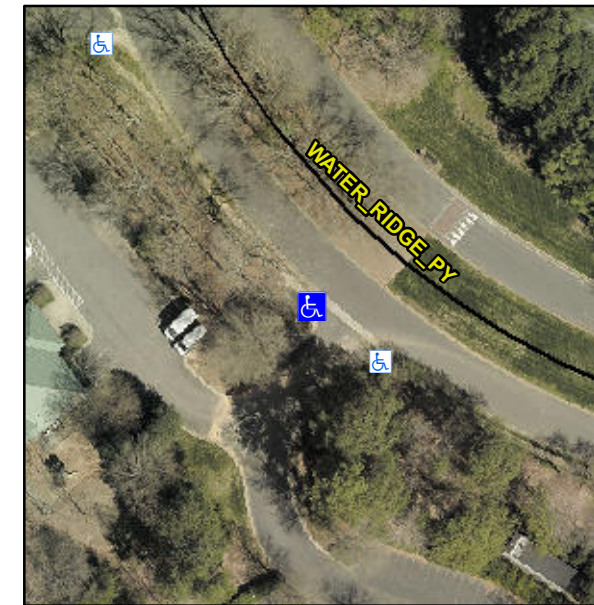
Compliance	Description	Data	Compliance	Description	Data
N/A	Ramp Length (in)	28.0	Yes	Ramp Slope (%)	5.2
Yes	Ramp Width (in)	60.0	No	Ramp XSlope (%)	6.1
N/A	Flare Type LT	N/A	N/A	Flare Type RT	N/A
N/A	Flare Slope LT (%)	N/A	N/A	Flare Slope RT (%)	N/A
N/A	Flare Traversable LT?	N/A	N/A	Flare Traversable RT?	N/A
N/A	Landing Length (in)	N/A	N/A	DWS Provided?	N/A
N/A	Landing Width (in)	N/A	N/A	DWS Contrast?	N/A
N/A	Landing Slope (%)	N/A	N/A	DWS Length (in)	N/A
N/A	Landing X Slope (%)	N/A	N/A	DWS Full Width?	N/A
N/A	Landing Curb? (Y/N)	N/A	N/A	DWS Offset (in)	N/A
N/A	Shared Landing?	N/A			
N/A	Gutter Ponding?	N/A	N/A	Gutter Slope (%)	N/A
N/A	Gutter Lip Ht (in)	N/A	N/A	Gutter X Slope (%)	N/A
N/A	Painted X Walk1?	No	N/A	Painted X Walk2?	No
	X Walk 1 Direction	To SE		X Walk 2 Direction	To NE
N/A	X Walk 1 Width (in)	N/A	N/A	X Walk 2 Width (in)	N/A
	X Walk 1 Slope (%)	0.2		X Walk 2 Slope (%)	2.2
	X Walk 1 X Slope (%)	0.6		X Walk 2 X Slope (%)	0.2

N/A	Ramp inside XWalk1?	N/A	N/A	Ramp inside XWalk2?	N/A
	Road Slope (%)	0.6	N/A	Clear Space?	N/A
	Road X Slope (%)	0.7	N/A	Clear Space to XWalk (in)	N/A
N/A	Any Obstructions?	N/A	N/A	Storm Grate/Utility Hazard?	N/A
	Obstruction Type			Storm Grate/Utility Type	
		N/A			N/A
		Yes		Surface Condition? (G/P)	Good

**Remove & Replace Curb Ramp With Two New Directional Ramps or Equivalent.**

**R304.5.3**
