# Access Compliance Report

## Public Rights-of-Way

### (Curb Ramps)

Intersection ID: 47569	Main Street: ROWE_CT	Cross Street: HERMSLEY_RD	Location: W
ADA ID: 5BD54FB8E11F	Ramp Type: PerpDiag	Initial Pass/Fail: Fail	Overall Compliance: No
Severity Score: 35			
Codes/Mitigation Info/Possible Solution		Field Measurements/Component Compliance

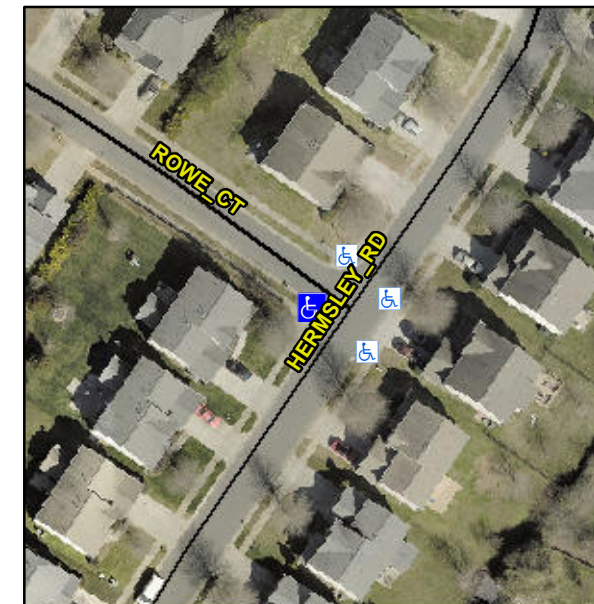
Compliance	Description	Data	Compliance	Description	Data
N/A	Ramp Length (in)	48.0	No	Ramp Slope (%)	15.1
No	Ramp Width (in)	47.5	No	Ramp XSlope (%)	4.7
N/A	Flare Type LT	N/A	N/A	Flare Type RT	N/A
N/A	Flare Slope LT (%)	N/A	N/A	Flare Slope RT (%)	N/A
N/A	Flare Traversable LT?	N/A	N/A	Flare Traversable RT?	N/A
N/A	Landing Length (in)	N/A	N/A	DWS Provided?	N/A
N/A	Landing Width (in)	N/A	N/A	DWS Contrast?	N/A
N/A	Landing Slope (%)	N/A	N/A	DWS Length (in)	N/A
N/A	Landing X Slope (%)	N/A	N/A	DWS Full Width?	N/A
N/A	Landing Curb? (Y/N)	N/A	N/A	DWS Offset (in)	N/A
N/A	Shared Landing?	N/A			
N/A	Gutter Ponding?	N/A	N/A	Gutter Slope (%)	N/A
N/A	Gutter Lip Ht (in)	N/A	N/A	Gutter X Slope (%)	N/A
N/A	Painted X Walk1?	No	N/A	Painted X Walk2?	No
	X Walk 1 Direction	To SE		X Walk 2 Direction	To NE
N/A	X Walk 1 Width (in)	N/A	N/A	X Walk 2 Width (in)	N/A
	X Walk 1 Slope (%)	2.1		X Walk 2 Slope (%)	3.0
	X Walk 1 X Slope (%)	2.6		X Walk 2 X Slope (%)	1.3

N/A	Ramp inside XWalk1?	N/A	N/A	Ramp inside XWalk2?	N/A
	Road Slope (%)	2.9	N/A	Clear Space?	N/A
	Road X Slope (%)	1.4	N/A	Clear Space to XWalk (in)	N/A
N/A	Any Obstructions?	N/A	N/A	Storm Grate/Utility Hazard?	N/A
	Obstruction Type			Storm Grate/Utility Type	
		N/A			N/A
			Yes	Surface Condition? (G/P)	Good

**Remove & Replace Curb Ramp With Two New Directional Ramps or Equivalent.**
