Access Compliance Report

Public Rights-of-Way

| Intersection ID: 10040584 | | Main Street: W_ARROWWOOD_RD | | Cross Street: N/A | | Location: | | SE | | | | | | | | | |
| ADA ID: 5C034B7CAB46 | | Ramp Type: Directional1 | | Initial Pass/Fail: Fail | | Overall Compliance: No | | Severity Score: 1.25 | | | | | | | | | |

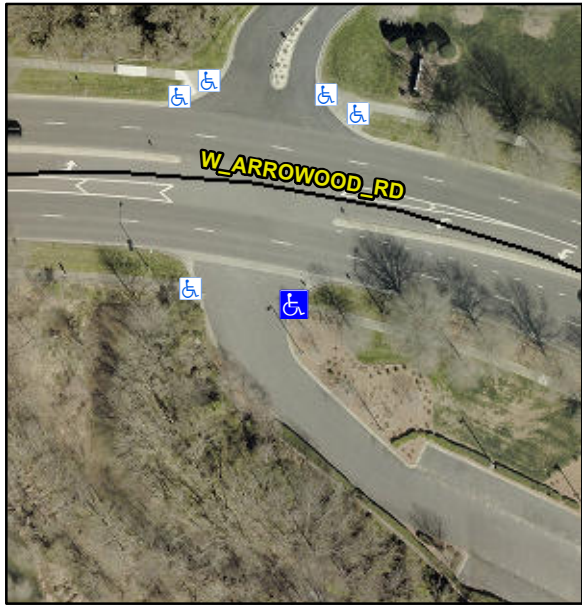
| PROW/ADA: | | | | R304.5.3 | | No | | Ramp XSlope (%) | | 5.0 | | N/A | | Flare Type RT | | N/A | |

| | | | | Remove & Replace Entire Ramp. | | N/A | | Ramp Length (in) | | 26.0 | | N/A | | Grade Break? | | N/A | |
