Access Compliance Report Public Rights-of-Way (Curb Ramps)

Intersection ID: 11188 Main Street: FOXFORD PL **Cross Street: PURSER DR** Location: N ADA ID: 5C05DC5A87FC Ramp Type: BlendTrans1 Initial Pass/Fail: Fail **Overall Compliance: No Severity Score:** 8.75

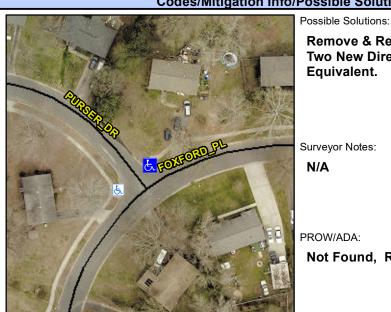
Not Found, R304.5.1

Field Measurements/Component Compliance					
Compliance Description		Data	Comp	liance Description	Data
N/A	Ramp Length (in)	86.5	Yes	BlendTrans Slope (%)	2.6
No	Ramp Width (in)	47.0	Yes	BlendTrans XSlope (%)	1.2
N/A	Flare Type LT	N/A	N/A	Flare Type RT	N/A
N/A	Flare Slope LT (%)	N/A	N/A	Flare Slope RT (%)	N/A
N/A	Flare Traversable LT?	N/A	N/A	Flare Traversable RT?	N/A
N/A	Landing Length (in)	N/A	N/A	DWS Provided?	N/A
N/A	Landing Width (in)	N/A	N/A	DWS Contrast?	N/A
N/A	Landing Slope (%)	N/A	N/A	DWS Length (in)	N/A
N/A	Landing X Slope (%)	N/A	N/A	DWS Full Width?	N/A
N/A	Landing Curb? (Y/N)	N/A	N/A	DWS Offset (in)	N/A
N/A	Shared Landing?	N/A			
N/A	Gutter Ponding?	N/A	N/A	Gutter Slope (%)	N/A
N/A	Gutter Lip Ht (in)	0.5	N/A	Gutter X Slope (%)	N/A
N/A	Painted X Walk1?	No	N/A	Painted X Walk2?	N/A
	X Walk 1 Direction	To SW		X Walk 2 Direction	N/A
	X Walk 1 Width (in)	N/A		X Walk 2 Width (in)	N/A
	X Walk 1 Slope (%)	0.3		X Walk 2 Slope (%)	N/A

X Walk 1 X Slope (%)	0.7		X Walk 2 X Slope (%)	N/A
N/A	Ramp inside XWalk1?	N/A	N/A	Ramp inside XWalk2?	N/A
	Road Slope (%)	0.7		Clear Space?	N/A
	Road X Slope (%)	0.3	N/A	Clear Space to XWalk (in)	N/A
N/A	Any Obstructions?	N/A	N/A	Storm Grate/Utility Hazard?	N/A
	Obstruction Type		l	Storm Grate/Utility Type	
		N/A	l		N/A
			Yes	Surface Condition? (G/P)	Good
			No	Curb Slope (%)	19.6

PURSER DR Street 1 Name Stop Condition-Street 1 StopSign Street 2 Name N/A Stop Condition-Street 2 N/A Remove & Replace Curb Ramp With Two New Directional Ramps or Equivalent.
