# Access Compliance Report

## Public Rights-of-Way

### (Curb Ramps)

| Intersection ID: 43227 | Main Street: N I-77_EXIT_5_RA | Cross Street: N I-77_HY | Location: S |

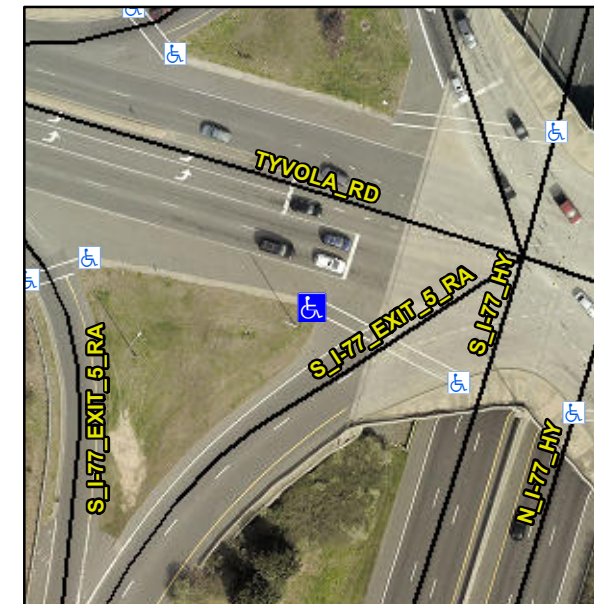
| ADA ID: 5C0A22623ED8 | Ramp Type: BlendTrans1 | Initial Pass/Fail: Fail | Overall Compliance: No |
| | | | Severity Score: 16.25 |

| Compliance | Description | Data | Compliance | Description | Data |
|---|---|---|---|---|---|
| | | No | | Surface Condition? (G/P) | Poor |

**Remove & Replace Curb Ramp With Two New Directional Ramps or Equivalent.**

**R302.7**

**\$ 3200.00**
