# Access Compliance Report

## Public Rights-of-Way

### (Curb Ramps)

| Intersection ID: 10093 | Main Street: MILTON_RD | Cross Street: THE_PLAZA | Location: SW |

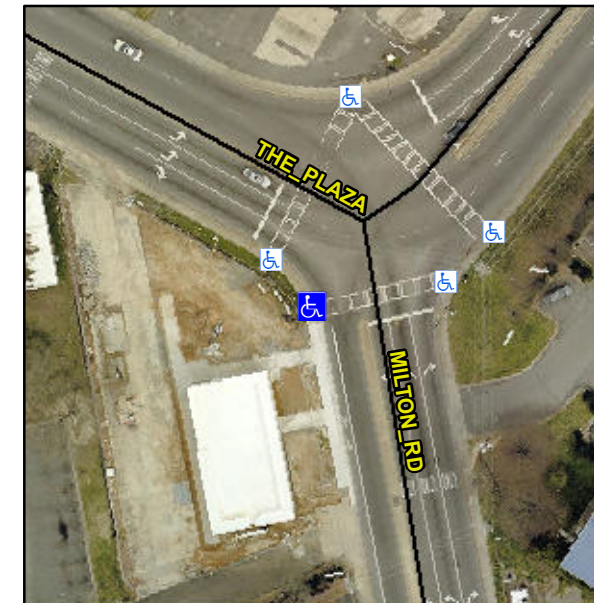
**Not Found, R304.2.2**

| Compliance | Description | Data | Compliance | Description | Data |
|---|---|---|---|---|---|
| N/A | Ramp Length (in) | 60.0 | No | Ramp Slope (%) | 8.7 |

**Remove & Replace Entire Ramp.**
