Access Compliance Report

Public Rights-of-Way

(Curb Ramps)

Intersection ID: 8857	Main Street: DORTON_ST	Cross Street: N_TRYON_ST	Location: SW
ADA ID: 5C17FE7946D3	Ramp Type: Perp	Initial Pass/Fail: Fail	Overall Compliance: No
Severity Score: 10			
Codes/Mitigation Info/Possible Solution		Field Measurements/Component Compliance

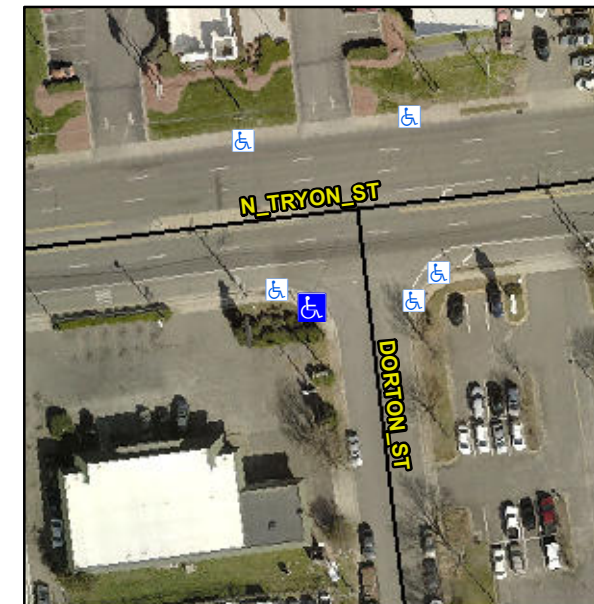
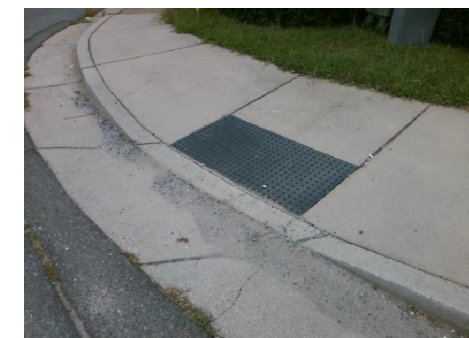
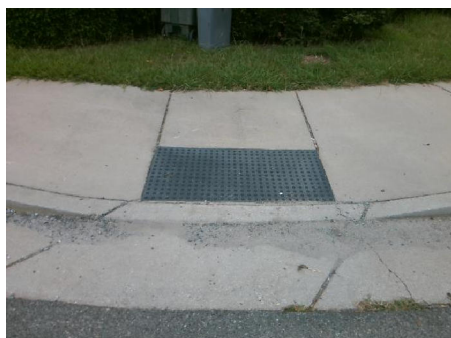
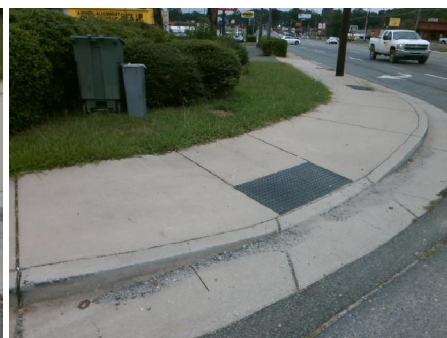
Not Found, R304.5.1, R304.5.3

Compliance	Description	Data	Compliance	Description	Data
N/A	Ramp Length (in)	66.5	Yes	Ramp Slope (%)	6.5
No	Ramp Width (in)	47.5	No	Ramp XSlope (%)	2.4
N/A	Flare Type LT	N/A	N/A	Flare Type RT	N/A
N/A	Flare Slope LT (%)	N/A	N/A	Flare Slope RT (%)	N/A
N/A	Flare Traversable LT?	N/A	N/A	Flare Traversable RT?	N/A
N/A	Landing Length (in)	N/A	N/A	DWS Provided?	N/A
N/A	Landing Width (in)	N/A	N/A	DWS Contrast?	N/A
N/A	Landing Slope (%)	N/A	N/A	DWS Length (in)	N/A
N/A	Landing X Slope (%)	N/A	N/A	DWS Full Width?	N/A
N/A	Landing Curb? (Y/N)	N/A	N/A	DWS Offset (in)	N/A
N/A	Shared Landing?	N/A			
N/A	Gutter Ponding?	N/A	N/A	Gutter Slope (%)	N/A
N/A	Gutter Lip Ht (in)	N/A	N/A	Gutter X Slope (%)	N/A
N/A	Painted X Walk1?	No	N/A	Painted X Walk2?	N/A
	X Walk 1 Direction	To E		X Walk 2 Direction	N/A
N/A	X Walk 1 Width (in)	N/A	N/A	X Walk 2 Width (in)	N/A
	X Walk 1 Slope (%)	3.9		X Walk 2 Slope (%)	N/A
	X Walk 1 X Slope (%)	0.5		X Walk 2 X Slope (%)	N/A

N/A	Ramp inside XWalk1?	N/A	N/A	Ramp inside XWalk2?	N/A
	Road Slope (%)	N/A	N/A	Clear Space?	N/A
	Road X Slope (%)	N/A	N/A	Clear Space to XWalk (in)	N/A
N/A	Any Obstructions?	N/A	N/A	Storm Grate/Utility Hazard?	N/A
	Obstruction Type			Storm Grate/Utility Type	
		N/A			N/A
			Yes	Surface Condition? (G/P)	Good

Remove & Replace Entire Ramp.

Total Cost: \$ 1850.00
