Access Compliance Report

Public Rights-of-Way

(Curb Ramps)

Intersection ID: 26531	Main Street: KUYKENDALL_RD	Cross Street: LANCELOT_DR	Location: SW
ADA ID: 5C1F4A8B0E9B	Ramp Type: PerpDiag	Initial Pass/Fail: Fail	Overall Compliance: No
			Severity Score: 13.75

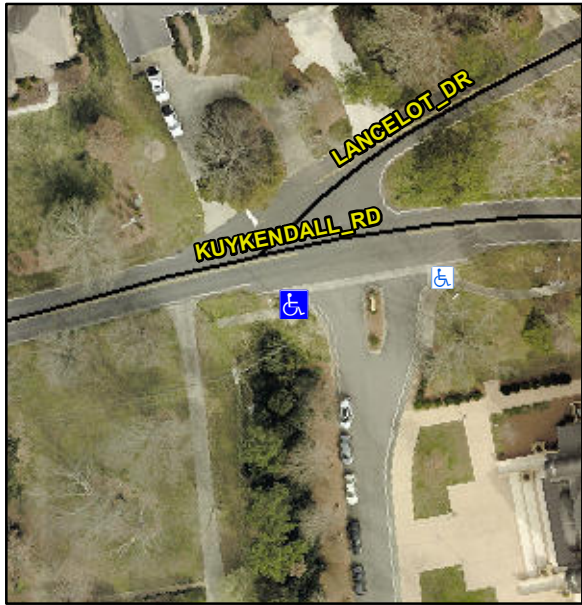
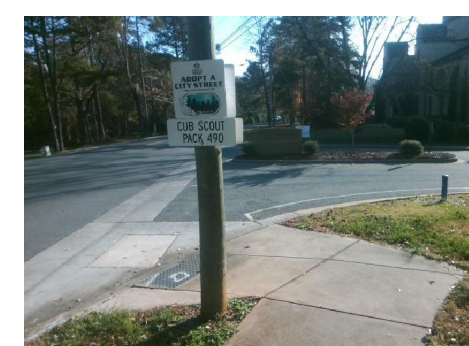
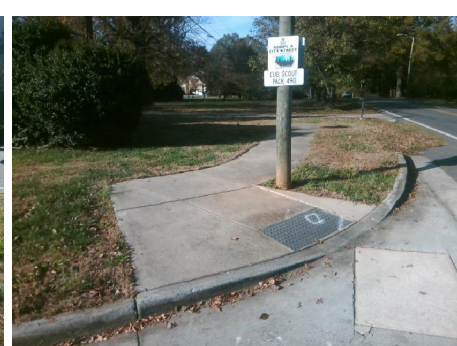
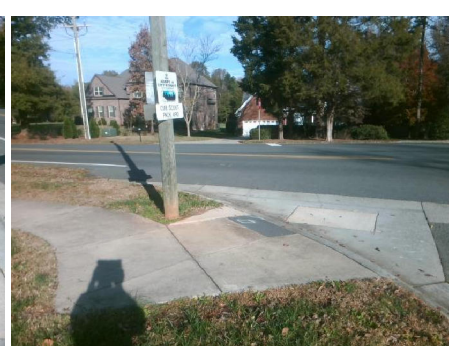
Possible Solutions:		Compliance	Description	Data	Compliance	Description	Data
	Remove & Replace Curb Ramp With Two New Directional Ramps or Equivalent.		N/A	Ramp Length (in)	74.0	No	Ramp Slope (%)	10.5
			Yes	Ramp Width (in)	49.0	Yes	Ramp XSlope (%)	2.7
			N/A	Flare Type LT	N/A	N/A	Flare Type RT	N/A
			N/A	Flare Slope LT (%)	N/A	N/A	Flare Slope RT (%)	N/A
			N/A	Flare Traversable LT?	N/A	N/A	Flare Traversable RT?	N/A
			N/A	Landing Length (in)	N/A	N/A	DWS Provided?	N/A
			N/A	Landing Width (in)	N/A	N/A	DWS Contrast?	N/A
			N/A	Landing Slope (%)	N/A	N/A	DWS Length (in)	N/A
			N/A	Landing X Slope (%)	N/A	N/A	DWS Full Width?	N/A
Surveyor Notes:		N/A	N/A	Landing Curb? (Y/N)	N/A	N/A	DWS Offset (in)	N/A
PROW/ADA:		Not Found, R304.2.2	N/A	Shared Landing?	N/A			
			N/A	Gutter Ponding?	N/A	N/A	Gutter Slope (%)	N/A
			N/A	Gutter Lip Ht (in)	N/A	N/A	Gutter X Slope (%)	N/A

N/A	Painted X Walk1?	No	N/A	Painted X Walk2?	No
				X Walk 1 Direction	To E		X Walk 2 Direction	To N
			N/A	X Walk 1 Width (in)	N/A	N/A	X Walk 2 Width (in)	N/A
				X Walk 1 Slope (%)	0.9		X Walk 2 Slope (%)	5.6
				X Walk 1 X Slope (%)	4.9		X Walk 2 X Slope (%)	1.8
			N/A	Ramp inside XWalk1?	N/A	N/A	Ramp inside XWalk2?	N/A
				Road Slope (%)	3.6	N/A	Clear Space?	N/A
				Road X Slope (%)	4.0	N/A	Clear Space to XWalk (in)	N/A
			N/A	Any Obstructions?	N/A	N/A	Storm Grate/Utility Hazard?	N/A
				Obstruction Type			Storm Grate/Utility Type	
					N/A			N/A
						Yes	Surface Condition? (G/P)	Good
Street 1 Name		ENTRANCE						
Stop Condition-Street 2		None						
Street 2 Name		KUYKENDALL RD						
Stop Condition-Street 1		None						
Total Cost:		\$ 3200.00
