# Access Compliance Report

## Public Rights-of-Way

### (Curb Ramps)

Intersection ID: 23398	Main Street: SHARON_RD_WEST	Cross Street: BRANDON_FOREST_DR	Location: SE
ADA ID: 5C222A5CD834	Ramp Type: PerpDiag	Initial Pass/Fail: Fail	Overall Compliance: No
Severity Score: 13.75			
Codes/Mitigation Info/Possible Solution		Field Measurements/Component Compliance

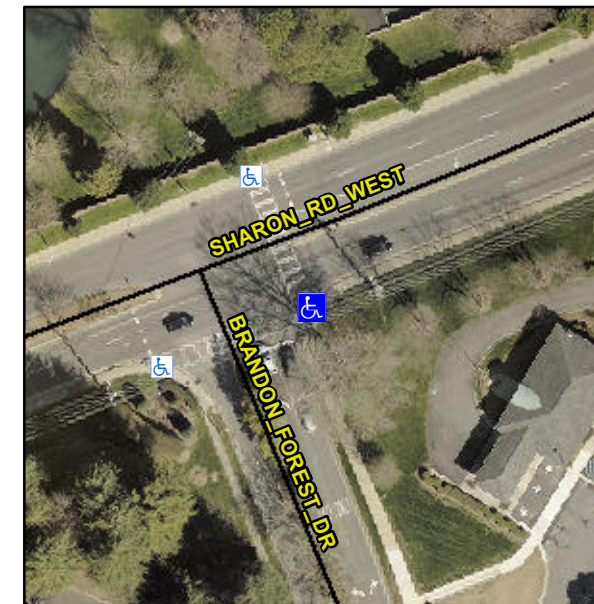
Compliance	Description	Data	Compliance	Description	Data
N/A	Ramp Length (in)	60.0	No	Ramp Slope (%)	8.5
Yes	Ramp Width (in)	48.0	Yes	Ramp XSlope (%)	2.5
N/A	Flare Type LT	N/A	N/A	Flare Type RT	N/A
N/A	Flare Slope LT (%)	N/A	N/A	Flare Slope RT (%)	N/A
N/A	Flare Traversable LT?	N/A	N/A	Flare Traversable RT?	N/A
N/A	Landing Length (in)	N/A	N/A	DWS Provided?	N/A
N/A	Landing Width (in)	N/A	N/A	DWS Contrast?	N/A
N/A	Landing Slope (%)	N/A	N/A	DWS Length (in)	N/A
N/A	Landing X Slope (%)	N/A	N/A	DWS Full Width?	N/A
N/A	Landing Curb? (Y/N)	N/A	N/A	DWS Offset (in)	N/A
N/A	Shared Landing?	N/A			
N/A	Gutter Ponding?	N/A	N/A	Gutter Slope (%)	N/A
N/A	Gutter Lip Ht (in)	N/A	N/A	Gutter X Slope (%)	N/A
N/A	Painted X Walk1?	Yes	N/A	Painted X Walk2?	Yes
	X Walk 1 Direction	To NW		X Walk 2 Direction	To SW
N/A	X Walk 1 Width (in)	111.0	N/A	X Walk 2 Width (in)	113.0
	X Walk 1 Slope (%)	2.1		X Walk 2 Slope (%)	3.8
	X Walk 1 X Slope (%)	2.9		X Walk 2 X Slope (%)	1.5

N/A	Ramp inside XWalk1?	Yes	N/A	Ramp inside XWalk2?	Yes
	Road Slope (%)	3.1	N/A	Clear Space?	N/A
	Road X Slope (%)	6.7	N/A	Clear Space to XWalk (in)	N/A
N/A	Any Obstructions?	N/A	N/A	Storm Grate/Utility Hazard?	N/A
	Obstruction Type			Storm Grate/Utility Type	
		N/A			N/A
		Yes		Surface Condition? (G/P)	Good

Possible Solutions:

**Remove & Replace Curb Ramp With Two New Directional Ramps or Equivalent.**
