Access Compliance Report Public Rights-of-Way (Curb Ramps)

Intersection ID: 10625 Main Street: ACADEMY ST **Cross Street: MEADOW LN** Location: NW ADA ID: 5C2CF952B0CA Ramp Type: PerpDiag Initial Pass/Fail: Fail **Overall Compliance: No** Severity Score: 21.25

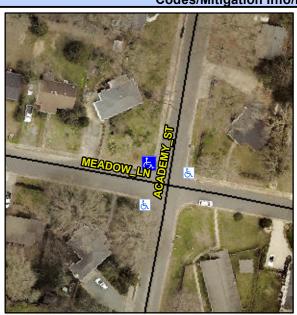
53.0 No

| Ramp Width (in) | 36.0 | Yes | Ramp XSlope (%) | 1.4 |

Possible Solutions: Remove & Replace Curb Ramp With Two New Directional Ramps or Equivalent.

R304.5.1, R304.2.2
