# Access Compliance Report

## Public Rights-of-Way

### (Curb Ramps)

Intersection ID: 51491	Main Street: N_TRYON_ST	Cross Street: INSTITUTE_CR	Location: E
ADA ID: 5C361D929DA4	Ramp Type: Perp	Initial Pass/Fail: Pass	Overall Compliance: No
Severity Score: 15			
Codes/Mitigation Info/Possible Solution		Field Measurements/Component Compliance

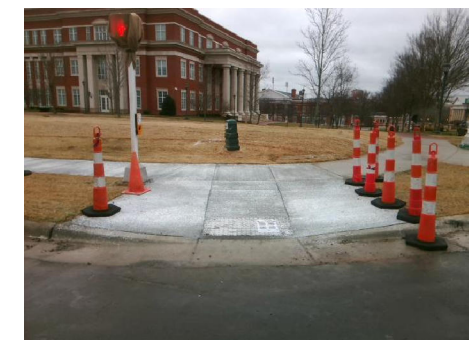
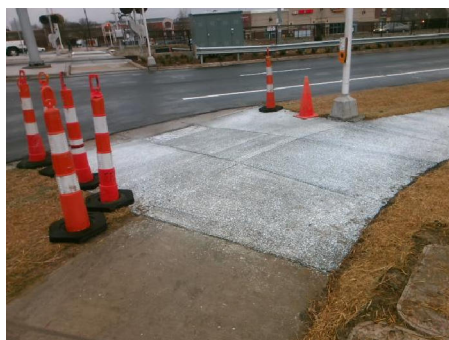
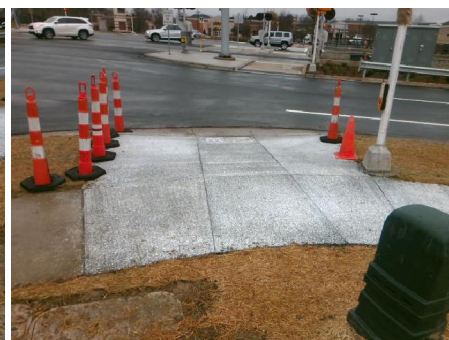
Compliance	Description	Data	Compliance	Description	Data
N/A	Ramp Length (in)	101.0	Yes	Ramp Slope (%)	7.1
Yes	Ramp Width (in)	48.0	Yes	Ramp XSlope (%)	0.1
N/A	Flare Type LT	Sloped	N/A	Flare Type RT	N/A
N/A	Flare Slope LT (%)	3.0	Yes	Flare Slope RT (%)	8.4
N/A	Flare Traversable LT?	Yes	N/A	Flare Traversable RT?	Yes
Yes	Landing Length (in)	71.0	Yes	DWS Provided?	Yes
Yes	Landing Width (in)	49.0	Yes	DWS Contrast?	Yes
Yes	Landing Slope (%)	0.7	Yes	DWS Length (in)	24.0
Yes	Landing X Slope (%)	0.6	Yes	DWS Full Width?	Yes
N/A	Landing Curb? (Y/N)	No	No	DWS Offset (in)	2.5
N/A	Shared Landing?	No			
Yes	Gutter Ponding?	No	Yes	Gutter Slope (%)	0.1
No	Gutter Lip Ht (in)	2.0	Yes	Gutter X Slope (%)	1.5
N/A	Painted X Walk1?	No	N/A	Painted X Walk2?	N/A
	X Walk 1 Direction	To NW		X Walk 2 Direction	N/A
N/A	X Walk 1 Width (in)	N/A	N/A	X Walk 2 Width (in)	N/A
	X Walk 1 Slope (%)	0.9		X Walk 2 Slope (%)	N/A
	X Walk 1 X Slope (%)	4.3		X Walk 2 X Slope (%)	N/A

N/A	Ramp inside XWalk1?	N/A	N/A	Ramp inside XWalk2?	N/A
	Road Slope (%)	N/A	N/A	Clear Space?	Yes
	Road X Slope (%)	N/A	N/A	Clear Space to XWalk (in)	N/A
Yes	Any Obstructions?	No	Yes	Storm Grate/Utility Hazard?	No
	Obstruction Type			Storm Grate/Utility Type	
		N/A			N/A
			Yes	Surface Condition? (G/P)	Good

**Remove & Replace Detectable Warning System. Grind Gutter Lip.**

**R305.2, R302.7.2**
