Access Compliance Report

Public Rights-of-Way

(Curb Ramps)

Intersection ID: 48770	Main Street: TURNING_WHEEL_DR	Cross Street: KNOTHOLE_LN	Location: SE
ADA ID: 5C43FD221859	Ramp Type: Perp	Initial Pass/Fail: Fail	Overall Compliance: No
Severity Score: 8.75			
Codes/Mitigation Info/Possible Solution		Field Measurements/Component Compliance

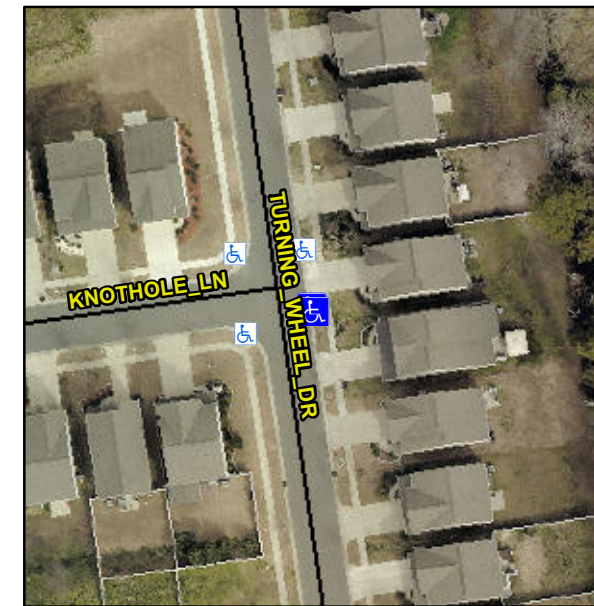
Compliance	Description	Data	Compliance	Description	Data
N/A	Ramp Length (in)	73.0	Yes	Ramp Slope (%)	7.6
No	Ramp Width (in)	47.5	Yes	Ramp XSlope (%)	1.8
N/A	Flare Type LT	N/A	N/A	Flare Type RT	N/A
N/A	Flare Slope LT (%)	N/A	N/A	Flare Slope RT (%)	N/A
N/A	Flare Traversable LT?	N/A	N/A	Flare Traversable RT?	N/A
N/A	Landing Length (in)	N/A	N/A	DWS Provided?	N/A
N/A	Landing Width (in)	N/A	N/A	DWS Contrast?	N/A
N/A	Landing Slope (%)	N/A	N/A	DWS Length (in)	N/A
N/A	Landing X Slope (%)	N/A	N/A	DWS Full Width?	N/A
N/A	Landing Curb? (Y/N)	N/A	N/A	DWS Offset (in)	N/A
N/A	Shared Landing?	N/A			
N/A	Gutter Ponding?	N/A	N/A	Gutter Slope (%)	N/A
N/A	Gutter Lip Ht (in)	N/A	N/A	Gutter X Slope (%)	N/A
N/A	Painted X Walk1?	No	N/A	Painted X Walk2?	N/A
	X Walk 1 Direction	To W		X Walk 2 Direction	N/A
N/A	X Walk 1 Width (in)	N/A	N/A	X Walk 2 Width (in)	N/A
	X Walk 1 Slope (%)	4.2		X Walk 2 Slope (%)	N/A
	X Walk 1 X Slope (%)	1.4		X Walk 2 X Slope (%)	N/A

N/A	Ramp inside XWalk1?	N/A	N/A	Ramp inside XWalk2?	N/A
	Road Slope (%)	N/A	N/A	Clear Space?	N/A
	Road X Slope (%)	N/A	N/A	Clear Space to XWalk (in)	N/A
N/A	Any Obstructions?	N/A	N/A	Storm Grate/Utility Hazard?	N/A
	Obstruction Type			Storm Grate/Utility Type	
		N/A			N/A
		Yes		Surface Condition? (G/P)	Good

Possible Solutions:

Remove & Replace Entire Ramp.

Not Found, R304.5.1
