Access Compliance Report

Public Rights-of-Way

(Curb Ramps)

Intersection ID: 10024753	Main Street: DEER_SPRING_LN	Cross Street: N/A	Location: SE
ADA ID: 5C4D3995E6DB	Ramp Type: BlendTrans2	Initial Pass/Fail: Pass	Overall Compliance: No
Severity Score: 10.25			
Codes/Mitigation Info/Possible Solution		Field Measurements/Component Compliance

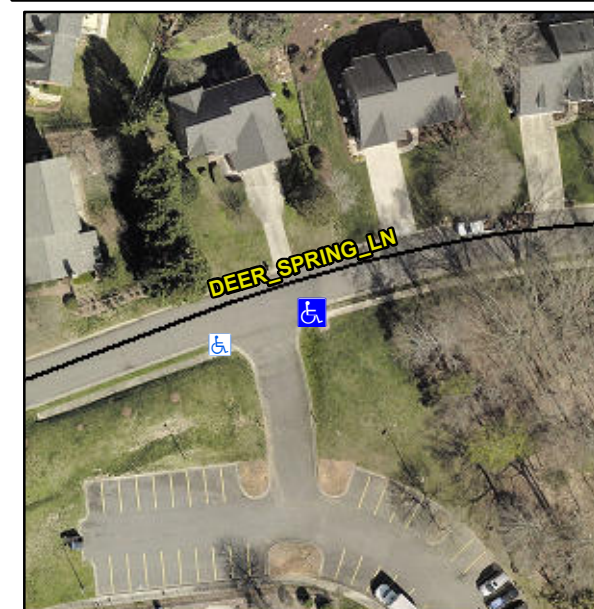
Not Found, R304.5.3, R305

Compliance	Description	Data	Compliance	Description	Data
N/A	Ramp Length (in)	48.0	Yes	BlendTrans Slope (%)	4.2
Yes	Ramp Width (in)	49.0	No	BlendTrans XSlope (%)	3.8
N/A	Flare Type LT	Sloped	N/A	Flare Type RT	Sloped
N/A	Flare Slope LT (%)	N/A	N/A	Flare Slope RT (%)	N/A
N/A	Flare Traversable LT?	No	N/A	Flare Traversable RT?	No
N/A	Landing Length (in)	N/A	No	DWS Provided?	No
N/A	Landing Width (in)	N/A	N/A	DWS Contrast?	No
N/A	Landing Slope (%)	N/A	N/A	DWS Length (in)	N/A
N/A	Landing X Slope (%)	N/A	N/A	DWS Full Width?	No
N/A	Landing Curb? (Y/N)	No	N/A	DWS Offset (in)	N/A
N/A	Shared Landing?	No			
Yes	Gutter Ponding?	No	Yes	Gutter Slope (%)	0.7
Yes	Gutter Lip Ht (in)	0.0	No	Gutter X Slope (%)	5.6
N/A	Painted X Walk1?	No	N/A	Painted X Walk2?	No
	X Walk 1 Direction	To N		X Walk 2 Direction	To SW
	X Walk 1 Width (in)	N/A		X Walk 2 Width (in)	N/A
	X Walk 1 Slope (%)	5.6		X Walk 2 Slope (%)	8.5
	X Walk 1 X Slope (%)	6.1		X Walk 2 X Slope (%)	2.5

N/A	Ramp inside XWalk1?	N/A	N/A	Ramp inside XWalk2?	N/A
	Road Slope (%)	2.6		Clear Space?	Yes
	Road X Slope (%)	9.1	N/A	Clear Space to XWalk (in)	N/A
Yes	Any Obstructions?	No	Yes	Storm Grate/Utility Hazard?	No
	Obstruction Type			Storm Grate/Utility Type	
		N/A			N/A
			Yes	Surface Condition? (G/P)	Good
			No	Curb Slope (%)	7.8

Remove & Replace Curb Ramp With Two New Directional Ramps or Equivalent. Remove & Replace Gutter.
