# Access Compliance Report

## Public Rights-of-Way

### (Curb Ramps)

Intersection ID: 21888	Main Street: ROCKLEDGE_DR	Cross Street: WATERCREST_RD	Location: SW
ADA ID: 5C4F242799B3	Ramp Type: BlendTrans2	Initial Pass/Fail: Fail	Overall Compliance: No
		Severity Score: 10

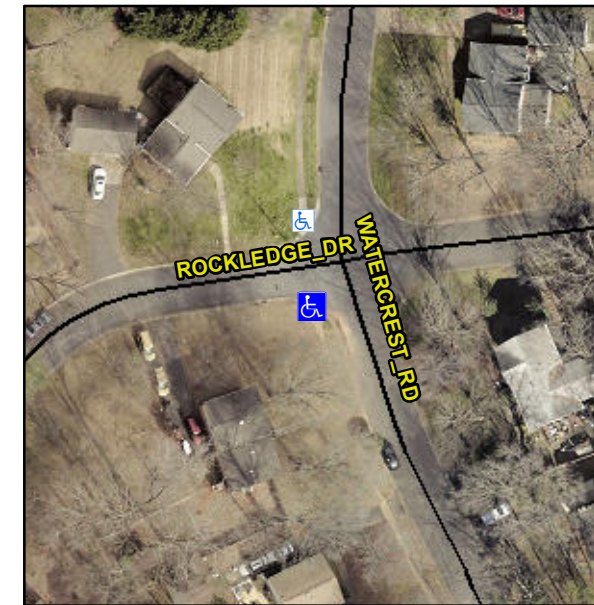
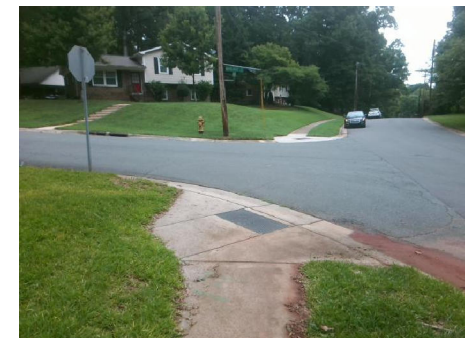
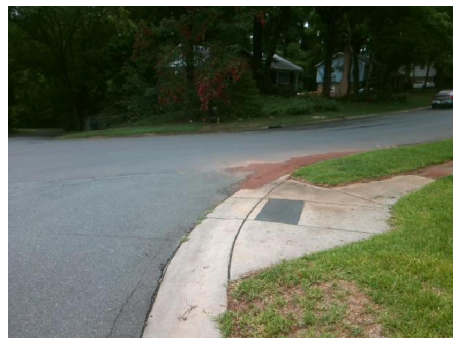
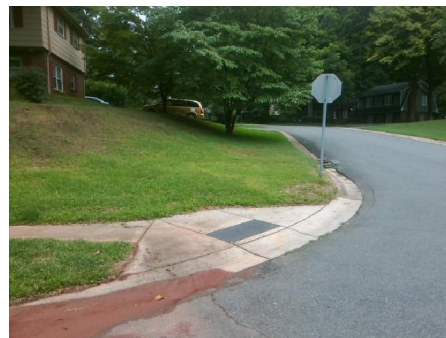
**Not Found, R304.5.1, R304.5.3**

Compliance	Description	Data	Compliance	Description	Data
N/A	Ramp Length (in)	84.0	Yes	BlendTrans Slope (%)	2.5
No	Ramp Width (in)	47.0	No	BlendTrans XSlope (%)	3.6
N/A	Flare Type LT	N/A	N/A	Flare Type RT	N/A
N/A	Flare Slope LT (%)	N/A	N/A	Flare Slope RT (%)	N/A
N/A	Flare Traversable LT?	N/A	N/A	Flare Traversable RT?	N/A
N/A	Landing Length (in)	N/A	N/A	DWS Provided?	N/A
N/A	Landing Width (in)	N/A	N/A	DWS Contrast?	N/A
N/A	Landing Slope (%)	N/A	N/A	DWS Length (in)	N/A
N/A	Landing X Slope (%)	N/A	N/A	DWS Full Width?	N/A
N/A	Landing Curb? (Y/N)	N/A	N/A	DWS Offset (in)	N/A
N/A	Shared Landing?	N/A			
N/A	Gutter Ponding?	N/A	N/A	Gutter Slope (%)	N/A
N/A	Gutter Lip Ht (in)	N/A	N/A	Gutter X Slope (%)	N/A
N/A	Painted X Walk1?	No	N/A	Painted X Walk2?	No
	X Walk 1 Direction	To E		X Walk 2 Direction	To N
	X Walk 1 Width (in)	N/A		X Walk 2 Width (in)	N/A
	X Walk 1 Slope (%)	1.5		X Walk 2 Slope (%)	4.0
	X Walk 1 X Slope (%)	3.7		X Walk 2 X Slope (%)	1.8

N/A	Ramp inside XWalk1?	N/A	N/A	Ramp inside XWalk2?	N/A
	Road Slope (%)	4.0		Clear Space?	N/A
	Road X Slope (%)	3.0	N/A	Clear Space to XWalk (in)	N/A
N/A	Any Obstructions?	N/A	N/A	Storm Grate/Utility Hazard?	N/A
	Obstruction Type			Storm Grate/Utility Type	
		N/A			N/A
			Yes	Surface Condition? (G/P)	Good
			No	Curb Slope (%)	21.0

**Remove & Replace Curb Ramp With Two New Directional Ramps or Equivalent.**
