# Access Compliance Report

## Public Rights-of-Way

### (Curb Ramps)

Intersection ID: 7516	Main Street: BEATTIES_FORD_RD	Cross Street: BISHOP_MADISON_LN	Location: NW
ADA ID: 5C5326957EED	Ramp Type: Perp	Initial Pass/Fail: Fail	Overall Compliance: No
Severity Score: 1.25			
Codes/Mitigation Info/Possible Solution		Field Measurements/Component Compliance

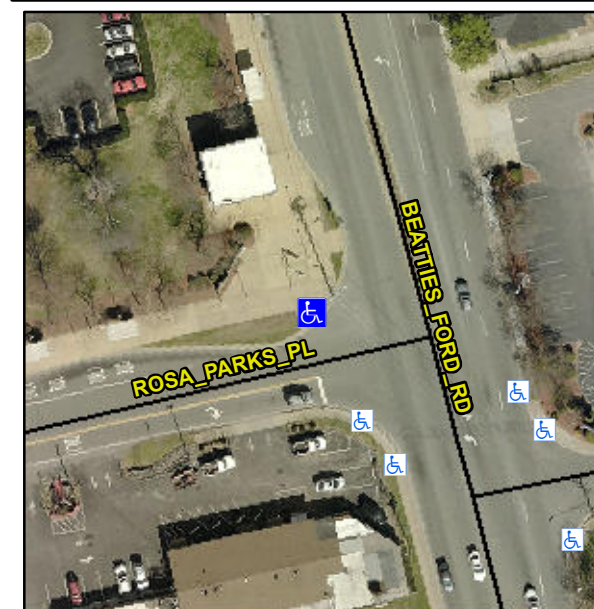
**Not Found, R304.5.3**

Compliance	Description	Data	Compliance	Description	Data
N/A	Ramp Length (in)	62.5	Yes	Ramp Slope (%)	6.8
Yes	Ramp Width (in)	48.0	No	Ramp XSlope (%)	2.7
N/A	Flare Type LT	N/A	N/A	Flare Type RT	N/A
N/A	Flare Slope LT (%)	N/A	N/A	Flare Slope RT (%)	N/A
N/A	Flare Traversable LT?	N/A	N/A	Flare Traversable RT?	N/A
N/A	Landing Length (in)	N/A	N/A	DWS Provided?	N/A
N/A	Landing Width (in)	N/A	N/A	DWS Contrast?	N/A
N/A	Landing Slope (%)	N/A	N/A	DWS Length (in)	N/A
N/A	Landing X Slope (%)	N/A	N/A	DWS Full Width?	N/A
N/A	Landing Curb? (Y/N)	N/A	N/A	DWS Offset (in)	N/A
N/A	Shared Landing?	N/A			
N/A	Gutter Ponding?	N/A	N/A	Gutter Slope (%)	N/A
N/A	Gutter Lip Ht (in)	N/A	N/A	Gutter X Slope (%)	N/A
N/A	Painted X Walk1?	No	N/A	Painted X Walk2?	N/A
	X Walk 1 Direction	To S		X Walk 2 Direction	N/A
N/A	X Walk 1 Width (in)	N/A	N/A	X Walk 2 Width (in)	N/A
	X Walk 1 Slope (%)	3.1		X Walk 2 Slope (%)	N/A
	X Walk 1 X Slope (%)	1.8		X Walk 2 X Slope (%)	N/A

**Remove & Replace Entire Ramp.**

Total Cost: \$ 1850.00
