Access Compliance Report

Public Rights-of-Way

(Curb Ramps)

Intersection ID: N/A	Main Street: NATIONS_FORD_RD	Cross Street: N/A	Location: E
ADA ID: 5C5D96FC9E7C	Ramp Type: Para	Initial Pass/Fail: Pass	Overall Compliance: No
Codes/Mitigation Info/Possible Solution		Field Measurements/Component Compliance	
Severity Score: 0.25

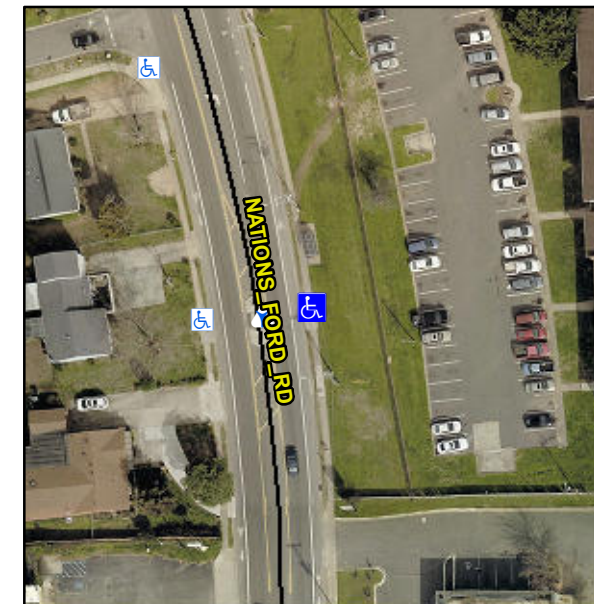
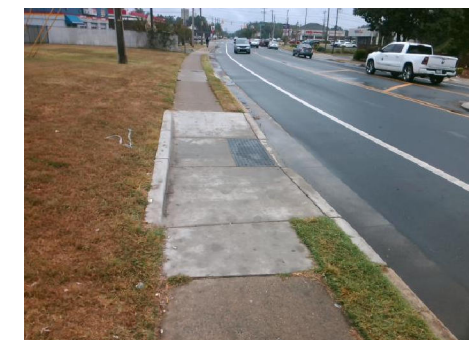
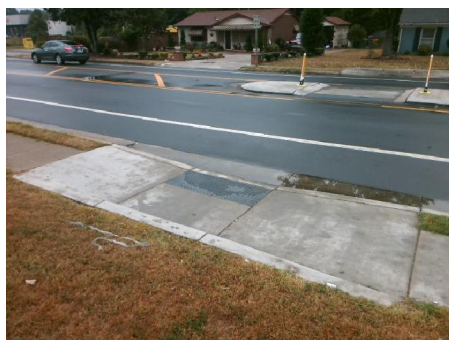
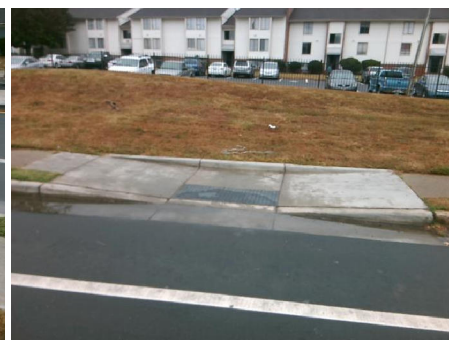
**Remove & Replace Entire Ramp.
Gutter Ponding Observed.**

Compliance	Description	Data	Compliance	Description	Data
N/A	Ramp Length LT (in)	75.0	N/A	Ramp Length RT (in)	74.0
Yes	Ramp Width LT (in)	64.5	Yes	Ramp Width RT (in)	63.0
Yes	Ramp Slope LT (%)	7.0	Yes	Ramp Slope RT (%)	7.7
Yes	Ramp XSlope LT (%)	1.6	No	Ramp XSlope RT (%)	3.6
Yes	Landing Length (in)	63.0	Yes	DWS Provided?	Yes
Yes	Landing Width (in)	60.0	Yes	DWS Contrast?	Yes
Yes	Landing Slope (%)	0.4	Yes	DWS Length (in)	24.0
Yes	Landing X Slope (%)	0.0	Yes	DWS Full Width?	Yes
N/A	Landing Curb? (Y/N)	Yes	Yes	DWS Offset (in)	1.0
N/A	Shared Landing?	No			
No	Gutter Ponding?	Yes	Yes	Gutter Slope (%)	0.7
Yes	Gutter Lip Ht (in)	0.0	Yes	Gutter X Slope (%)	0.5
N/A	Painted X Walk1?	No	N/A	Painted X Walk2?	N/A
	X Walk 1 Direction	To W		X Walk 2 Direction	N/A
N/A	X Walk 1 Width (in)	N/A	N/A	X Walk 2 Width (in)	N/A
	X Walk 1 Slope (%)	4.7		X Walk 2 Slope (%)	N/A
	X Walk 1 X Slope (%)	0.8		X Walk 2 X Slope (%)	N/A
N/A	Ramp inside XWalk1?	N/A	N/A	Ramp inside XWalk2?	N/A

Road Slope (%)	N/A	N/A	Clear Space?	Yes
	Road X Slope (%)	N/A	N/A	Clear Space to XWalk (in)	N/A
Yes	Any Obstructions?	No	Yes	Storm Grate/Utility Hazard?	No
	Obstruction Type			Storm Grate/Utility Type	
		N/A			N/A
			Yes	Surface Condition? (G/P)	Good
			N/A	Curb Slope (%)	9.3

Possible Solutions:

Total Cost: \$ 2100.00
