Access Compliance Report

Public Rights-of-Way

(Curb Ramps)

Intersection ID: 10777	Main Street: WESLEY_AV	Cross Street: WHITING_AV	Location: SW
ADA ID: 5C618D9A85FC	Ramp Type: PerpDiag	Initial Pass/Fail: Fail	Overall Compliance: No
		Severity Score: 22.5

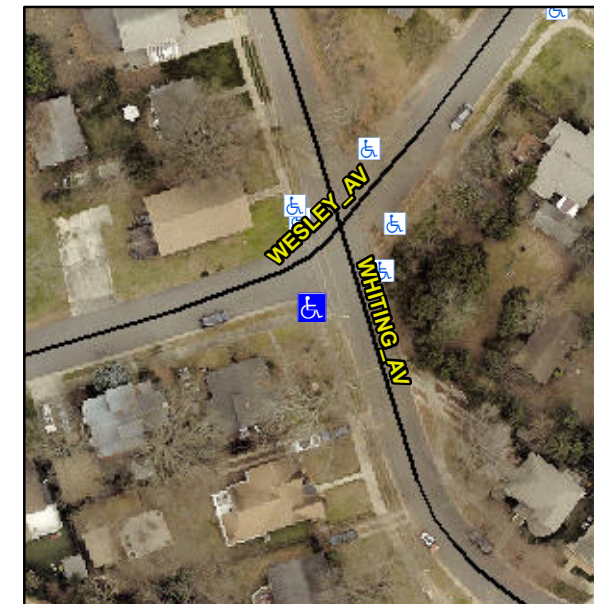
Not Found, R304.5.1, R304.2.2, R304.5.3

Compliance	Description	Data	Compliance	Description	Data
N/A	Ramp Length (in)	55.5	No	Ramp Slope (%)	10.6
No	Ramp Width (in)	39.0	No	Ramp XSlope (%)	2.3
N/A	Flare Type LT	N/A	N/A	Flare Type RT	N/A
N/A	Flare Slope LT (%)	N/A	N/A	Flare Slope RT (%)	N/A
N/A	Flare Traversable LT?	N/A	N/A	Flare Traversable RT?	N/A
N/A	Landing Length (in)	N/A	N/A	DWS Provided?	N/A
N/A	Landing Width (in)	N/A	N/A	DWS Contrast?	N/A
N/A	Landing Slope (%)	N/A	N/A	DWS Length (in)	N/A
N/A	Landing X Slope (%)	N/A	N/A	DWS Full Width?	N/A
N/A	Landing Curb? (Y/N)	N/A	N/A	DWS Offset (in)	N/A
N/A	Shared Landing?	N/A			
N/A	Gutter Ponding?	N/A	N/A	Gutter Slope (%)	N/A
N/A	Gutter Lip Ht (in)	N/A	N/A	Gutter X Slope (%)	N/A
N/A	Painted X Walk1?	No	N/A	Painted X Walk2?	No
	X Walk 1 Direction	To E		X Walk 2 Direction	To N
N/A	X Walk 1 Width (in)	N/A	N/A	X Walk 2 Width (in)	N/A
	X Walk 1 Slope (%)	7.3		X Walk 2 Slope (%)	0.8
	X Walk 1 X Slope (%)	5.6		X Walk 2 X Slope (%)	7.4

N/A	Ramp inside XWalk1?	N/A	N/A	Ramp inside XWalk2?	N/A
	Road Slope (%)	7.3	N/A	Clear Space?	N/A
	Road X Slope (%)	6.9	N/A	Clear Space to XWalk (in)	N/A
N/A	Any Obstructions?	N/A	N/A	Storm Grate/Utility Hazard?	N/A
	Obstruction Type			Storm Grate/Utility Type	
		N/A			N/A
			Yes	Surface Condition? (G/P)	Good

Remove & Replace Curb Ramp With Two New Directional Ramps or Equivalent.
