# Access Compliance Report

## Public Rights-of-Way

### (Curb Ramps)

| Intersection ID: 6421 | Main Street: S SHOPPING CENTER DR | Cross Street: UNIVERSITY CITY BV | Location: | N |

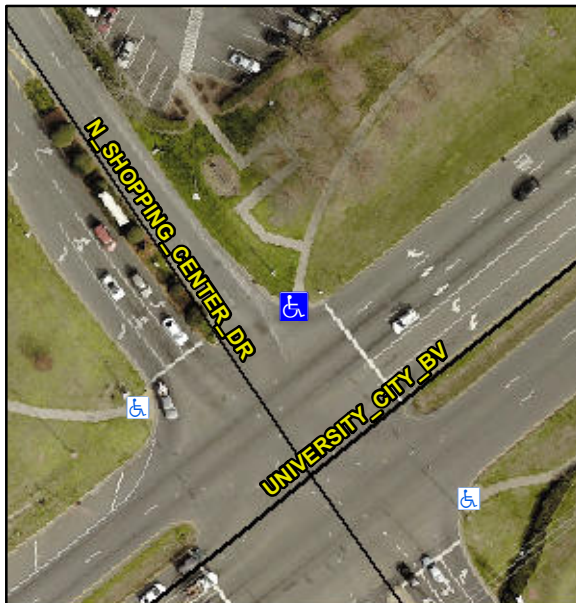
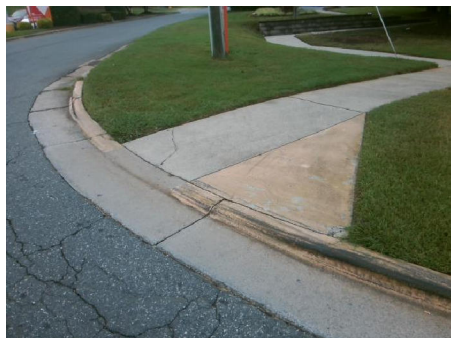
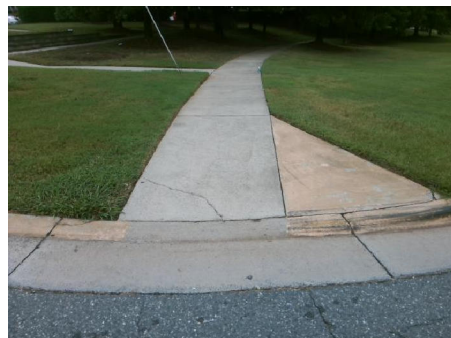
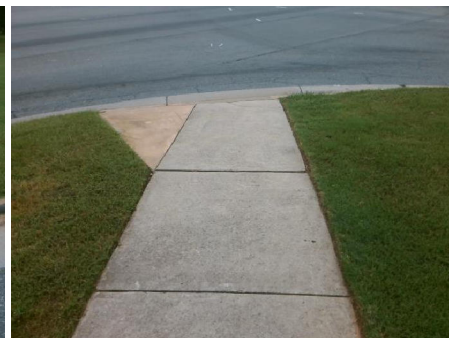
| ADA ID: 5C63E49E91E1 | Ramp Type: PerpDiag | Initial Pass/Fail: Fail | Overall Compliance: No | Severity Score: 37.5 |

**Not Found, R304.2.2, R304.5.3**

| Compliance | Description | Data | Compliance | Description | Data |
|---|---|---|---|---|---|
| N/A | Ramp Length (in) | 110.0 | No | Ramp Slope (%) | 8.6 |
| Yes | Ramp Width (in) | 58.0 | No | Ramp XSlope (%) | 8.6 |

**Remove & Replace Curb Ramp With Two New Directional Ramps or Equivalent.**
