# Access Compliance Report

## Public Rights-of-Way

### (Curb Ramps)

| Intersection ID: 10032734 | Main Street: N_SHARON_AMITY_RD | Cross Street: N/A | Location: SW |

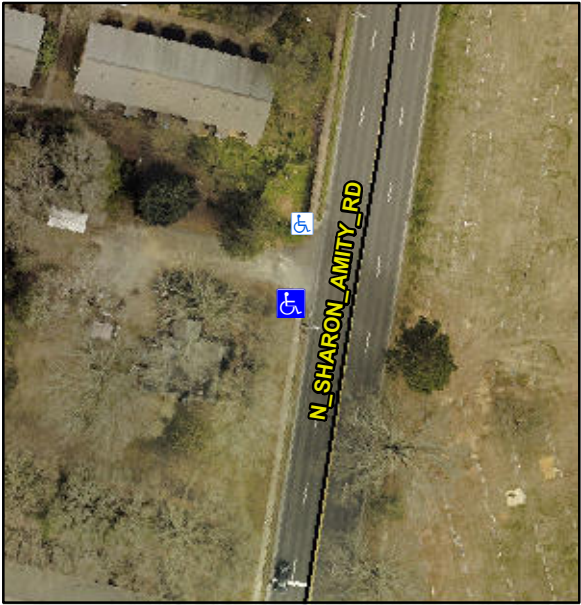
| ADA ID: 5C669381F77D | Ramp Type: PerpDiag | Initial Pass/Fail: Fail | Overall Compliance: No |
| Severity Score: 13.75 | | | |

| | Remove & Replace Curb Ramp With Two New Directional Ramps or Equivalent. | N/A | Ramp Length (in) | 62.0 | No | Ramp Slope (%) | 11.9 |
| | | Yes | Ramp Width (in) | 48.0 | No | Ramp XSlope (%) | 3.1 |
| <p>Surveyor Notes:</p> <p>N/A</p> <p>PROW/ADA:</p> <p>Not Found, R304.2.2, R304.5.3</p> | | | Road Slope (%) | 2.9 | N/A | Clear Space? | N/A |
