Access Compliance Report Public Rights-of-Way (Curb Ramps)

Intersection ID: 43155 Main Street: E W T HARRIS BV **Cross Street: LINDA LAKE DR** Location: NW **Overall Compliance: No** ADA ID: 5C6EBAF925B3 Ramp Type: PerpDiag Initial Pass/Fail: Fail Severity Score: 21.25

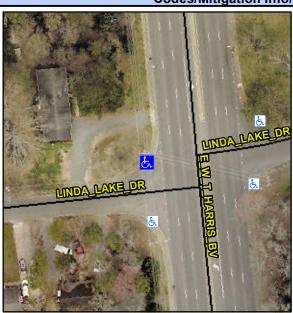
Total Cost: 3200.00 Compliance Description Data Compliance Description Data No N/A Ramp Length (in) 60.5 Ramp Slope (%) 10.3 Yes Ramp XSlope (%) No Ramp Width (in) 36.0 1.4 N/A N/A Flare Type LT N/A Flare Type RT N/A N/A N/A Flare Slope RT (%) N/A Flare Slope LT (%) N/A N/A Flare Traversable LT? N/A N/A Flare Traversable RT? N/A N/A N/A N/A **DWS Provided?** N/A Landing Length (in) N/A Landing Width (in) N/A N/A **DWS Contrast?** N/A N/A N/A Landing Slope (%) N/A DWS Length (in) N/A N/A Landing X Slope (%) N/A N/A DWS Full Width? N/A N/A Landing Curb? (Y/N) N/A N/A DWS Offset (in) N/A N/A N/A Shared Landing? N/A **Gutter Ponding?** N/A N/A Gutter Slope (%) N/A N/A Gutter Lip Ht (in) 1.0 N/A Gutter X Slope (%) N/A N/A Painted X Walk1? No N/A Painted X Walk2? No X Walk 1 Direction To S X Walk 2 Direction To E N/A N/A X Walk 2 Width (in) X Walk 1 Width (in) N/A X Walk 1 Slope (%) X Walk 2 Slope (%) 3.1 3.5 X Walk 2 X Slope (%) X Walk 1 X Slope (%) 1.4 2.2 N/A N/A N/A Ramp inside XWalk2? N/A Ramp inside XWalk1? Road Slope (%) 0.4 N/A Clear Space? N/A N/A Road X Slope (%) 6.2 Clear Space to XWalk (in) N/A N/A N/A N/A Any Obstructions? Storm Grate/Utility Hazard? N/A **Obstruction Type** Storm Grate/Utility Type N/A N/A

Possible Solutions: Remove & Replace Curb Ramp With Two New Directional Ramps or Equivalent. Surveyor Notes: N/A PROW/ADA: Not Found, R304.5.1, R304.2.2
