# Access Compliance Report

## Public Rights-of-Way

### (Curb Ramps)

Intersection ID: 28372	Main Street: CONSTITUTION_HALL_DR	Cross Street: HIGHLANDS_CROSSING_DR	Location: SE
ADA ID: 5C6F48ED6C86	Ramp Type: PerpDiag	Initial Pass/Fail: Fail	Overall Compliance: No
		Severity Score: 12.5

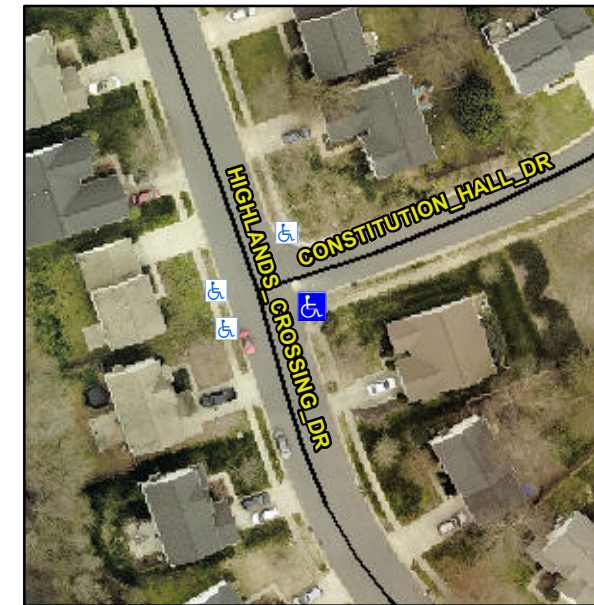
**Not Found, R304.5.3**

Compliance	Description	Data	Compliance	Description	Data
N/A	Ramp Length (in)	42.0	Yes	Ramp Slope (%)	6.5
Yes	Ramp Width (in)	48.0	No	Ramp XSlope (%)	6.7
N/A	Flare Type LT	N/A	N/A	Flare Type RT	N/A
N/A	Flare Slope LT (%)	N/A	N/A	Flare Slope RT (%)	N/A
N/A	Flare Traversable LT?	N/A	N/A	Flare Traversable RT?	N/A
N/A	Landing Length (in)	N/A	N/A	DWS Provided?	N/A
N/A	Landing Width (in)	N/A	N/A	DWS Contrast?	N/A
N/A	Landing Slope (%)	N/A	N/A	DWS Length (in)	N/A
N/A	Landing X Slope (%)	N/A	N/A	DWS Full Width?	N/A
N/A	Landing Curb? (Y/N)	N/A	N/A	DWS Offset (in)	N/A
N/A	Shared Landing?	N/A			
N/A	Gutter Ponding?	N/A	N/A	Gutter Slope (%)	N/A
N/A	Gutter Lip Ht (in)	N/A	N/A	Gutter X Slope (%)	N/A
N/A	Painted X Walk1?	No	N/A	Painted X Walk2?	No
	X Walk 1 Direction	To N		X Walk 2 Direction	To W
N/A	X Walk 1 Width (in)	N/A	N/A	X Walk 2 Width (in)	N/A
	X Walk 1 Slope (%)	3.0		X Walk 2 Slope (%)	1.0
	X Walk 1 X Slope (%)	4.1		X Walk 2 X Slope (%)	2.3

N/A	Ramp inside XWalk1?	N/A	N/A	Ramp inside XWalk2?	N/A
	Road Slope (%)	2.3	N/A	Clear Space?	N/A
	Road X Slope (%)	0.7	N/A	Clear Space to XWalk (in)	N/A
N/A	Any Obstructions?	N/A	N/A	Storm Grate/Utility Hazard?	N/A
	Obstruction Type			Storm Grate/Utility Type	
		N/A			N/A
			Yes	Surface Condition? (G/P)	Good

**Remove & Replace Curb Ramp With Two New Directional Ramps or Equivalent.**
