Access Compliance Report

Public Rights-of-Way

(Curb Ramps)

Intersection ID: 12701	Main Street: HICKORY GROVE RD	Cross Street: MARKET ST	Location: NE
ADA ID: 5C7C8803D31B	Ramp Type: PerpDiag	Initial Pass/Fail: Fail	Overall Compliance: No
Codes/Mitigation Info/Possible Solution			Severity Score: 35
			Field Measurements/Component Compliance

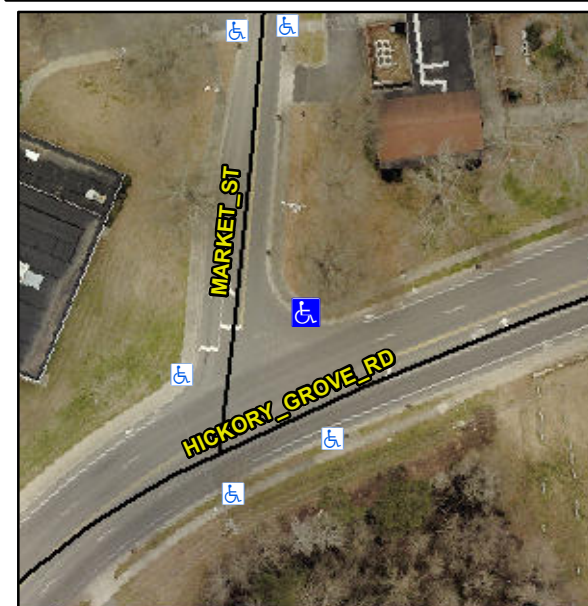
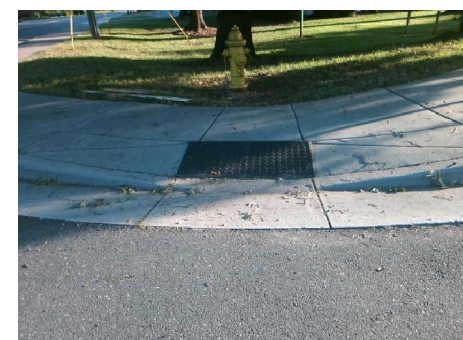
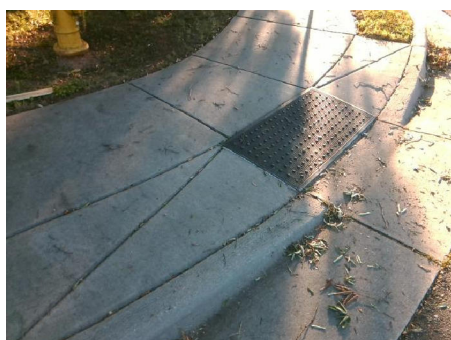
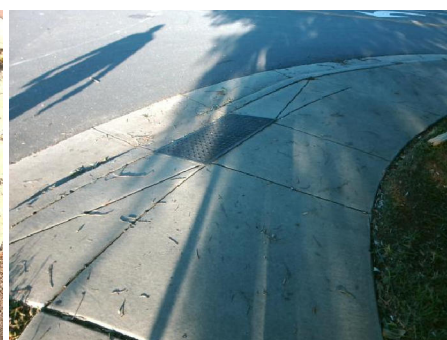
R304.5.1, R304.2.2, R304.5.3

Compliance	Description	Data	Compliance	Description	Data
N/A	Ramp Length (in)	25.0	No	Ramp Slope (%)	16.1
No	Ramp Width (in)	40.0	No	Ramp XSlope (%)	2.8
N/A	Flare Type LT	N/A	N/A	Flare Type RT	N/A
N/A	Flare Slope LT (%)	N/A	N/A	Flare Slope RT (%)	N/A
N/A	Flare Traversable LT?	N/A	N/A	Flare Traversable RT?	N/A
N/A	Landing Length (in)	N/A	N/A	DWS Provided?	N/A
N/A	Landing Width (in)	N/A	N/A	DWS Contrast?	N/A
N/A	Landing Slope (%)	N/A	N/A	DWS Length (in)	N/A
N/A	Landing X Slope (%)	N/A	N/A	DWS Full Width?	N/A
N/A	Landing Curb? (Y/N)	N/A	N/A	DWS Offset (in)	N/A
N/A	Shared Landing?	N/A			
N/A	Gutter Ponding?	N/A	N/A	Gutter Slope (%)	N/A
N/A	Gutter Lip Ht (in)	N/A	N/A	Gutter X Slope (%)	N/A
N/A	Painted X Walk1?	No	N/A	Painted X Walk2?	No
	X Walk 1 Direction	To SW		X Walk 2 Direction	To S
N/A	X Walk 1 Width (in)	N/A	N/A	X Walk 2 Width (in)	N/A
	X Walk 1 Slope (%)	0.7		X Walk 2 Slope (%)	1.9
	X Walk 1 X Slope (%)	0.7		X Walk 2 X Slope (%)	3.2

N/A	Ramp inside XWalk1?	N/A	N/A	Ramp inside XWalk2?	N/A
	Road Slope (%)	2.3	N/A	Clear Space?	N/A
	Road X Slope (%)	0.7	N/A	Clear Space to XWalk (in)	N/A
N/A	Any Obstructions?	N/A	N/A	Storm Grate/Utility Hazard?	N/A
	Obstruction Type			Storm Grate/Utility Type	
		N/A			N/A
			Yes	Surface Condition? (G/P)	Good

Remove & Replace Curb Ramp With Two New Directional Ramps or Equivalent.
