# Access Compliance Report

## Public Rights-of-Way (Curb Ramps)

| Intersection ID: N/A | Main Street: PAISLEY_ABBEY_LN | Cross Street: KELBURN_LN | Location: NW |
| ADA ID: 5C7E3F2AF0F2 | Ramp Type: BlendTrans1 | Initial Pass/Fail: Fail | Overall Compliance: No |

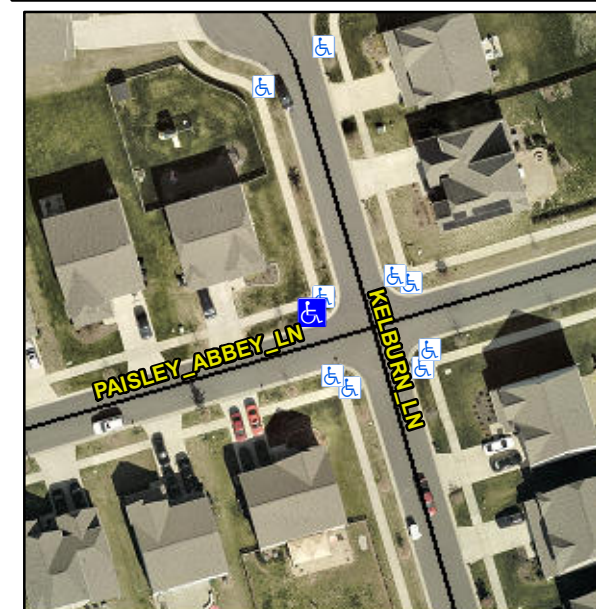
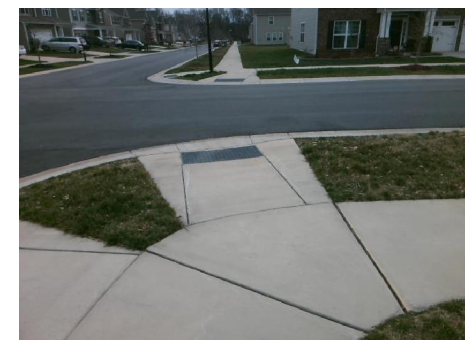
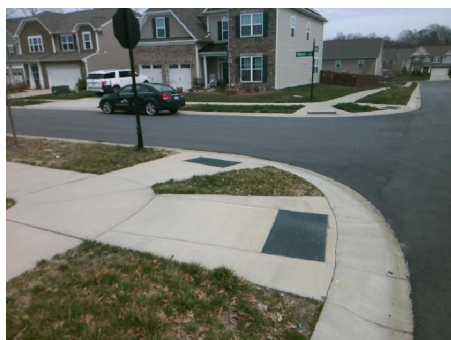
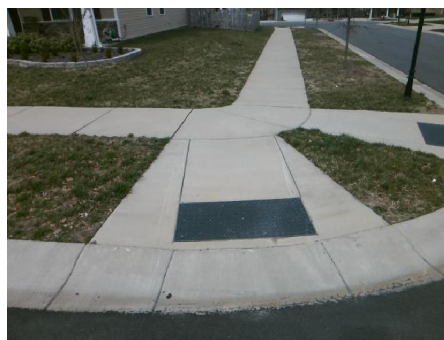
| Severity Score: 21.25 | | | |

| Compliance | Description | Data | Compliance | Description | Data |
|---|---|---|---|---|---|
| N/A | Ramp Length (in) | 97.0 | Yes | BlendTrans Slope (%) | 2.7 |
| No | Ramp Width (in) | 47.0 | No | BlendTrans XSlope (%) | 5.3 |

Possible Solutions:

**Remove & Replace Curb Ramp With Two New Directional Ramps or Equivalent.**

**R304.5.1, R304.5.3**

Total Cost: \$ 3200.00
