Access Compliance Report

Public Rights-of-Way

(Curb Ramps)

Intersection ID: 11650	Main Street: W_10TH_ST	Cross Street: N_CHURCH_ST	Location: W
ADA ID: 5C8F5424FAC4	Ramp Type: PerpDiag	Initial Pass/Fail: Fail	Overall Compliance: No
			Severity Score: 33.75

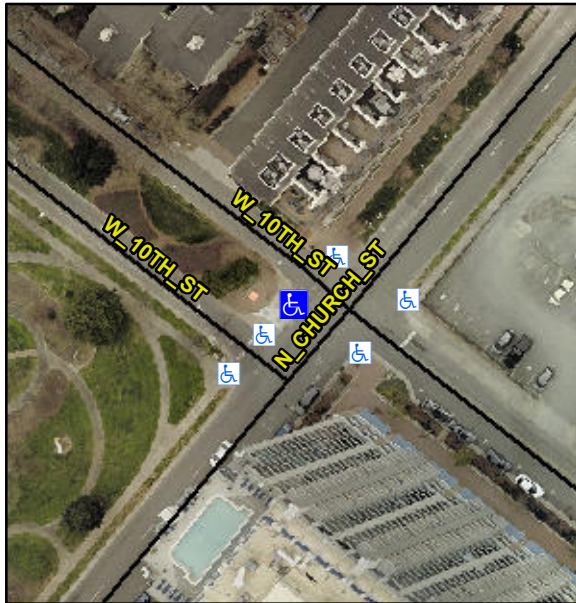
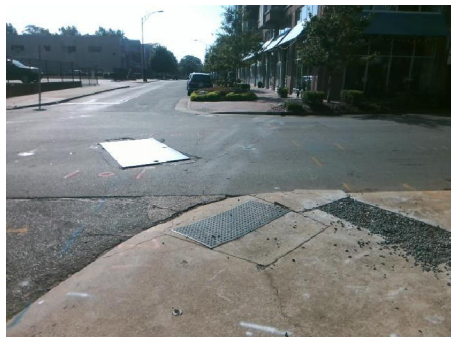
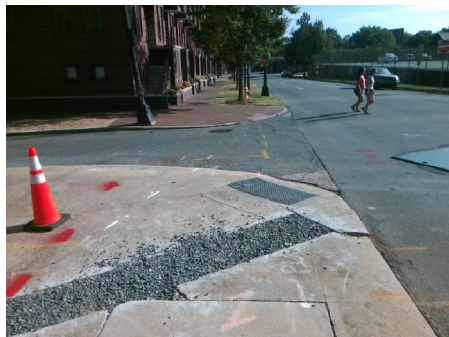
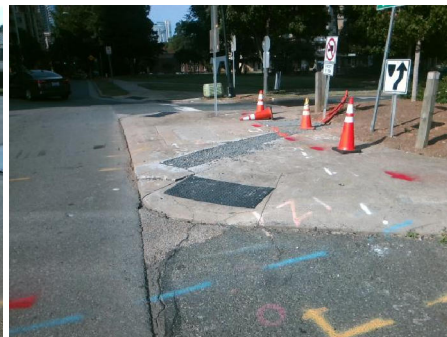
Not Found, R304.5.1, R304.2.2, R304.5.3

Compliance	Description	Data	Compliance	Description	Data
N/A	Ramp Length (in)	62.0	No	Ramp Slope (%)	9.4
No	Ramp Width (in)	41.0	No	Ramp XSlope (%)	6.2
N/A	Flare Type LT	N/A	N/A	Flare Type RT	N/A
N/A	Flare Slope LT (%)	N/A	N/A	Flare Slope RT (%)	N/A
N/A	Flare Traversable LT?	N/A	N/A	Flare Traversable RT?	N/A
N/A	Landing Length (in)	N/A	N/A	DWS Provided?	N/A
N/A	Landing Width (in)	N/A	N/A	DWS Contrast?	N/A
N/A	Landing Slope (%)	N/A	N/A	DWS Length (in)	N/A
N/A	Landing X Slope (%)	N/A	N/A	DWS Full Width?	N/A
N/A	Landing Curb? (Y/N)	N/A	N/A	DWS Offset (in)	N/A
N/A	Shared Landing?	N/A			
N/A	Gutter Ponding?	N/A	N/A	Gutter Slope (%)	N/A
N/A	Gutter Lip Ht (in)	N/A	N/A	Gutter X Slope (%)	N/A
N/A	Painted X Walk1?	No	N/A	Painted X Walk2?	No
	X Walk 1 Direction	To SE		X Walk 2 Direction	To NE
N/A	X Walk 1 Width (in)	N/A	N/A	X Walk 2 Width (in)	N/A
	X Walk 1 Slope (%)	4.3		X Walk 2 Slope (%)	2.1
	X Walk 1 X Slope (%)	2.8		X Walk 2 X Slope (%)	0.1

N/A	Ramp inside XWalk1?	N/A	N/A	Ramp inside XWalk2?	N/A
	Road Slope (%)	5.2	N/A	Clear Space?	N/A
	Road X Slope (%)	3.3	N/A	Clear Space to XWalk (in)	N/A
N/A	Any Obstructions?	N/A	N/A	Storm Grate/Utility Hazard?	N/A
	Obstruction Type			Storm Grate/Utility Type	
		N/A			N/A
			Yes	Surface Condition? (G/P)	Good

Remove & Replace Curb Ramp With Two New Directional Ramps or Equivalent.
