# Access Compliance Report

## Public Rights-of-Way

### (Curb Ramps)

Intersection ID: 18026	Main Street: E_INDEPENDENCE_BV	Cross Street: WALLACE_LN	Location: NE
ADA ID: 5C916157316A	Ramp Type: Perp	Initial Pass/Fail: Fail	Overall Compliance: No Severity Score: 13.75

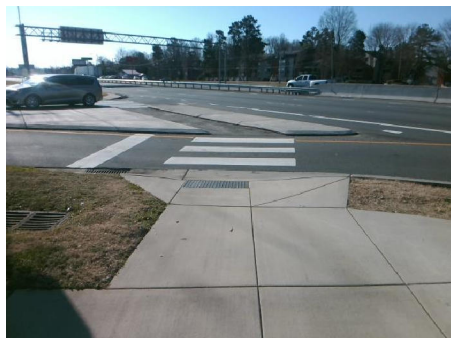
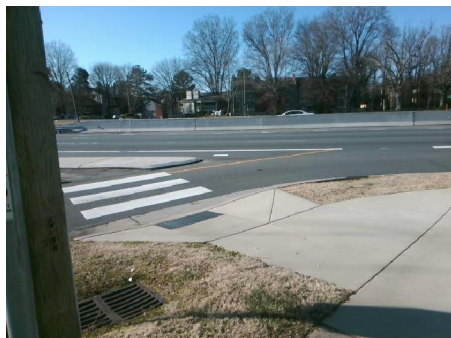
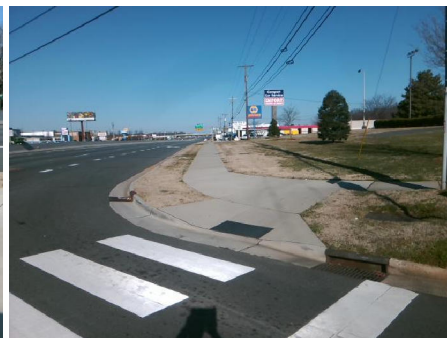
**Not Found, R304.2.2, R304.5.3**

Compliance	Description	Data	Compliance	Description	Data
N/A	Ramp Length (in)	157.0	No	Ramp Slope (%)	9.0
Yes	Ramp Width (in)	49.0	No	Ramp XSlope (%)	4.1
N/A	Flare Type LT	N/A	N/A	Flare Type RT	N/A
N/A	Flare Slope LT (%)	N/A	N/A	Flare Slope RT (%)	N/A
N/A	Flare Traversable LT?	N/A	N/A	Flare Traversable RT?	N/A
N/A	Landing Length (in)	N/A	N/A	DWS Provided?	N/A
N/A	Landing Width (in)	N/A	N/A	DWS Contrast?	N/A
N/A	Landing Slope (%)	N/A	N/A	DWS Length (in)	N/A
N/A	Landing X Slope (%)	N/A	N/A	DWS Full Width?	N/A
N/A	Landing Curb? (Y/N)	N/A	N/A	DWS Offset (in)	N/A
N/A	Shared Landing?	N/A			
N/A	Gutter Ponding?	N/A	N/A	Gutter Slope (%)	N/A
N/A	Gutter Lip Ht (in)	N/A	N/A	Gutter X Slope (%)	N/A
N/A	Painted X Walk1?	Yes	N/A	Painted X Walk2?	N/A
	X Walk 1 Direction	To SE		X Walk 2 Direction	N/A
N/A	X Walk 1 Width (in)	121.0	N/A	X Walk 2 Width (in)	N/A
	X Walk 1 Slope (%)	3.8		X Walk 2 Slope (%)	N/A
	X Walk 1 X Slope (%)	2.6		X Walk 2 X Slope (%)	N/A

N/A	Ramp inside XWalk1?	Yes	N/A	Ramp inside XWalk2?	N/A
	Road Slope (%)	N/A	N/A	Clear Space?	N/A
	Road X Slope (%)	N/A	N/A	Clear Space to XWalk (in)	N/A
N/A	Any Obstructions?	N/A	N/A	Storm Grate/Utility Hazard?	N/A
	Obstruction Type			Storm Grate/Utility Type	
		N/A			N/A
			Yes	Surface Condition? (G/P)	Good

**Remove & Replace Entire Ramp.**
