# Access Compliance Report

## Public Rights-of-Way

### (Curb Ramps)

Intersection ID: 29405	Main Street: GOLD_PAN_RD	Cross Street: REEDY_PLANTATION_RD	Location: SE
ADA ID: 5C945CF77752	Ramp Type: BlendTrans1	Initial Pass/Fail: Pass	Overall Compliance: No
		Severity Score: 0

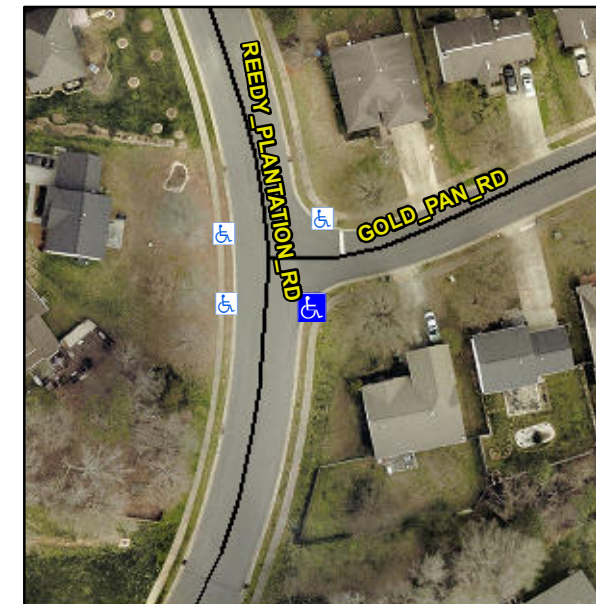
**Not Found, R304.2.1, R305.2**

Compliance	Description	Data	Compliance	Description	Data
N/A	Ramp Length (in)	53.5	Yes	BlendTrans Slope (%)	1.7
Yes	Ramp Width (in)	48.0	Yes	BlendTrans XSlope (%)	2.0
N/A	Flare Type LT	Sloped	N/A	Flare Type RT	Sloped
N/A	Flare Slope LT (%)	3.9	N/A	Flare Slope RT (%)	2.8
N/A	Flare Traversable LT?	No	N/A	Flare Traversable RT?	No
No	Landing Length (in)	46.5	Yes	DWS Provided?	Yes
Yes	Landing Width (in)	48.0	Yes	DWS Contrast?	Yes
Yes	Landing Slope (%)	0.0	Yes	DWS Length (in)	24.0
Yes	Landing X Slope (%)	0.7	Yes	DWS Full Width?	Yes
N/A	Landing Curb? (Y/N)	No	No	DWS Offset (in)	4.0
N/A	Shared Landing?	No			
Yes	Gutter Ponding?	No	Yes	Gutter Slope (%)	2.1
Yes	Gutter Lip Ht (in)	0.0	Yes	Gutter X Slope (%)	0.7
N/A	Painted X Walk1?	No	N/A	Painted X Walk2?	No
	X Walk 1 Direction	To N		X Walk 2 Direction	To W
	X Walk 1 Width (in)	N/A		X Walk 2 Width (in)	N/A
	X Walk 1 Slope (%)	3.6		X Walk 2 Slope (%)	4.0
	X Walk 1 X Slope (%)	2.7		X Walk 2 X Slope (%)	3.9

N/A	Ramp inside XWalk1?	N/A	N/A	Ramp inside XWalk2?	N/A
	Road Slope (%)	1.4		Clear Space?	Yes
	Road X Slope (%)	5.2	N/A	Clear Space to XWalk (in)	N/A
Yes	Any Obstructions?	No	Yes	Storm Grate/Utility Hazard?	No
	Obstruction Type			Storm Grate/Utility Type	
		N/A			N/A
			Yes	Surface Condition? (G/P)	Good
			No	Curb Slope (%)	13.7

**Remove & Replace Curb Ramp With Two New Directional Ramps or Equivalent.**

Total Cost: \$ 3200.00
