Access Compliance Report

Public Rights-of-Way

(Curb Ramps)

Intersection ID: 15102	Main Street: QUEENS_RD	Cross Street: E_MOREHEAD_ST	Location: W
ADA ID: 5C961483A53E	Ramp Type: PerpDiag	Initial Pass/Fail: Fail	Overall Compliance: No
			Severity Score: 13.75

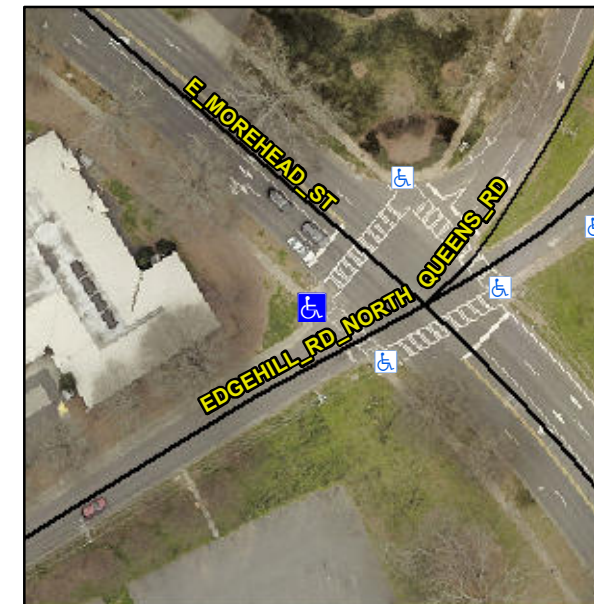
Not Found, R304.2.2

Compliance	Description	Data	Compliance	Description	Data
N/A	Ramp Length (in)	89.0	No	Ramp Slope (%)	9.0
Yes	Ramp Width (in)	48.0	Yes	Ramp XSlope (%)	2.7
N/A	Flare Type LT	N/A	N/A	Flare Type RT	N/A
N/A	Flare Slope LT (%)	N/A	N/A	Flare Slope RT (%)	N/A
N/A	Flare Traversable LT?	N/A	N/A	Flare Traversable RT?	N/A
N/A	Landing Length (in)	N/A	N/A	DWS Provided?	N/A
N/A	Landing Width (in)	N/A	N/A	DWS Contrast?	N/A
N/A	Landing Slope (%)	N/A	N/A	DWS Length (in)	N/A
N/A	Landing X Slope (%)	N/A	N/A	DWS Full Width?	N/A
N/A	Landing Curb? (Y/N)	N/A	N/A	DWS Offset (in)	N/A
N/A	Shared Landing?	N/A			
N/A	Gutter Ponding?	N/A	N/A	Gutter Slope (%)	N/A
N/A	Gutter Lip Ht (in)	N/A	N/A	Gutter X Slope (%)	N/A
N/A	Painted X Walk1?	Yes	N/A	Painted X Walk2?	Yes
	X Walk 1 Direction	To SE		X Walk 2 Direction	To NE
N/A	X Walk 1 Width (in)	85.0	N/A	X Walk 2 Width (in)	104.0
	X Walk 1 Slope (%)	0.3		X Walk 2 Slope (%)	6.1
	X Walk 1 X Slope (%)	4.3		X Walk 2 X Slope (%)	0.2

N/A	Ramp inside XWalk1?	Yes	N/A	Ramp inside XWalk2?	Yes
	Road Slope (%)	2.8	N/A	Clear Space?	N/A
	Road X Slope (%)	1.5	N/A	Clear Space to XWalk (in)	N/A
N/A	Any Obstructions?	N/A	N/A	Storm Grate/Utility Hazard?	N/A
	Obstruction Type			Storm Grate/Utility Type	
		N/A			N/A
		Yes		Surface Condition? (G/P)	Good

Possible Solutions:

Remove & Replace Curb Ramp With Two New Directional Ramps or Equivalent.

Total Cost: \$ 3200.00
