Access Compliance Report

Public Rights-of-Way

(Curb Ramps)

Intersection ID: 3282	Main Street: OAK_ST	Cross Street: ERNEST_RUSSELL_CT	Location: W
ADA ID: 5C9EE4C4F238	Ramp Type: PerpDiag	Initial Pass/Fail: Fail	Overall Compliance: No
Severity Score: 22.5			
Codes/Mitigation Info/Possible Solution		Field Measurements/Component Compliance

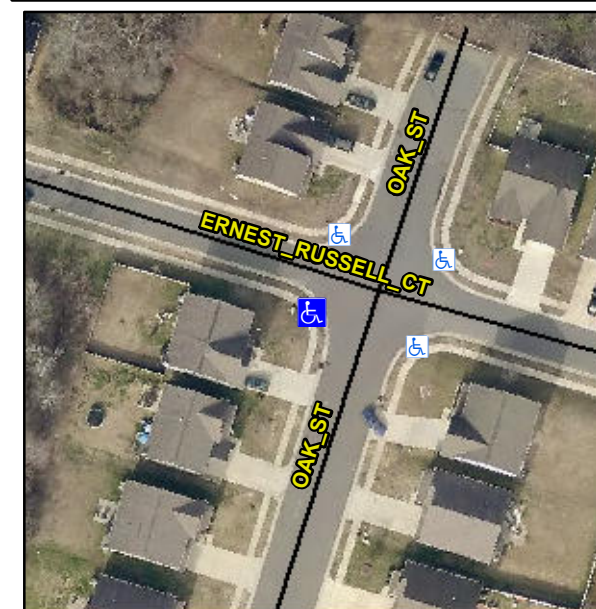
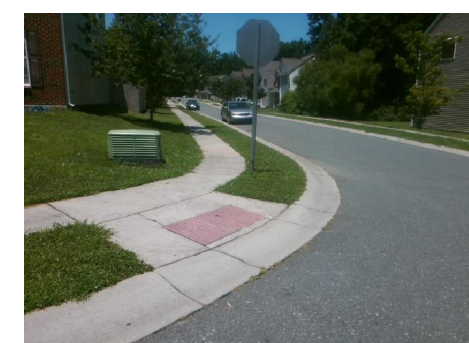
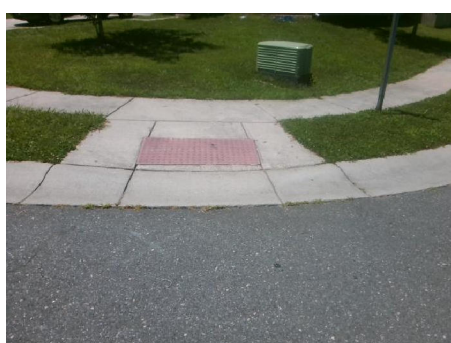
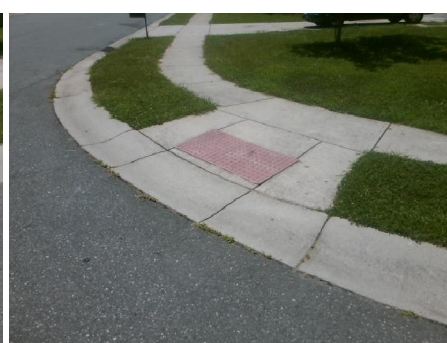
Not Found, R304.5.1, R304.2.2, R304.5.3

Compliance	Description	Data	Compliance	Description	Data
N/A	Ramp Length (in)	50.0	No	Ramp Slope (%)	11.0
No	Ramp Width (in)	42.0	No	Ramp XSlope (%)	4.2
N/A	Flare Type LT	N/A	N/A	Flare Type RT	N/A
N/A	Flare Slope LT (%)	N/A	N/A	Flare Slope RT (%)	N/A
N/A	Flare Traversable LT?	N/A	N/A	Flare Traversable RT?	N/A
N/A	Landing Length (in)	N/A	N/A	DWS Provided?	N/A
N/A	Landing Width (in)	N/A	N/A	DWS Contrast?	N/A
N/A	Landing Slope (%)	N/A	N/A	DWS Length (in)	N/A
N/A	Landing X Slope (%)	N/A	N/A	DWS Full Width?	N/A
N/A	Landing Curb? (Y/N)	N/A	N/A	DWS Offset (in)	N/A
N/A	Shared Landing?	N/A			
N/A	Gutter Ponding?	N/A	N/A	Gutter Slope (%)	N/A
N/A	Gutter Lip Ht (in)	N/A	N/A	Gutter X Slope (%)	N/A
N/A	Painted X Walk1?	No	N/A	Painted X Walk2?	No
	X Walk 1 Direction	To SE		X Walk 2 Direction	To NE
N/A	X Walk 1 Width (in)	N/A	N/A	X Walk 2 Width (in)	N/A
	X Walk 1 Slope (%)	1.7		X Walk 2 Slope (%)	3.2
	X Walk 1 X Slope (%)	2.6		X Walk 2 X Slope (%)	0.5

N/A	Ramp inside XWalk1?	N/A	N/A	Ramp inside XWalk2?	N/A
	Road Slope (%)	2.4	N/A	Clear Space?	N/A
	Road X Slope (%)	2.6	N/A	Clear Space to XWalk (in)	N/A
N/A	Any Obstructions?	N/A	N/A	Storm Grate/Utility Hazard?	N/A
	Obstruction Type			Storm Grate/Utility Type	
		N/A			N/A
			Yes	Surface Condition? (G/P)	Good

Remove & Replace Curb Ramp With Two New Directional Ramps or Equivalent.
