Access Compliance Report

Public Rights-of-Way

(Curb Ramps)

Intersection ID: 16024	Main Street: JONQUIL_ST	Cross Street: MARVIN_RD	Location: NW
ADA ID: 5CA384FADC95	Ramp Type: ParaDiag	Initial Pass/Fail: Fail	Overall Compliance: No
Severity Score: 13.75			
Codes/Mitigation Info/Possible Solution		Field Measurements/Component Compliance

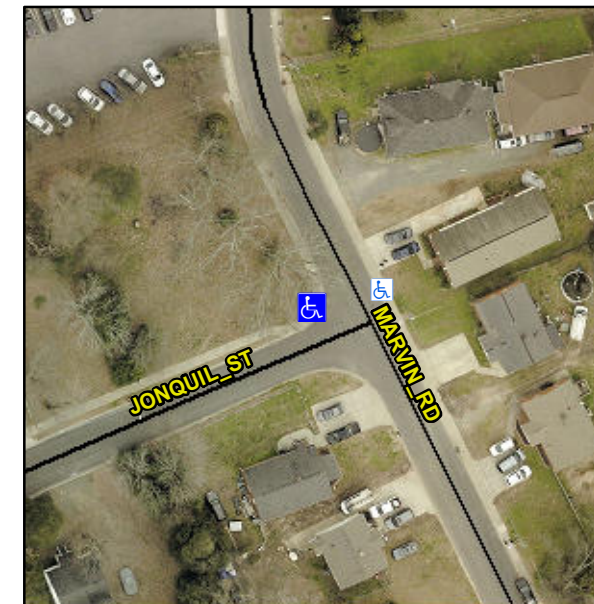
RT RP < 5%

Compliance	Description	Data	Compliance	Description	Data
N/A	Ramp Length LT (in)	21.5	N/A	Ramp Length RT (in)	17.0
Yes	Ramp Width LT (in)	56.5	Yes	Ramp Width RT (in)	57.5
No	Ramp Slope LT (%)	11.3	Yes	Ramp Slope RT (%)	0.1
Yes	Ramp XSlope LT (%)	1.4	No	Ramp XSlope RT (%)	2.6
N/A	Landing Length (in)	N/A	N/A	DWS Provided?	N/A
N/A	Landing Width (in)	N/A	N/A	DWS Contrast?	N/A
N/A	Landing Slope (%)	N/A	N/A	DWS Length (in)	N/A
N/A	Landing X Slope (%)	N/A	N/A	DWS Full Width?	N/A
N/A	Landing Curb? (Y/N)	N/A	N/A	DWS Offset (in)	N/A
N/A	Shared Landing?	N/A			
N/A	Gutter Ponding?	N/A	N/A	Gutter Slope (%)	N/A
N/A	Gutter Lip Ht (in)	N/A	N/A	Gutter X Slope (%)	N/A
N/A	Painted X Walk1?	No	N/A	Painted X Walk2?	No
	X Walk 1 Direction	To SE		X Walk 2 Direction	To NE
N/A	X Walk 1 Width (in)	N/A	N/A	X Walk 2 Width (in)	N/A
	X Walk 1 Slope (%)	4.2		X Walk 2 Slope (%)	1.6
	X Walk 1 X Slope (%)	2.3		X Walk 2 X Slope (%)	4.2
N/A	Ramp inside XWalk1?	N/A	N/A	Ramp inside XWalk2?	N/A

Road Slope (%)	1.8	N/A	Clear Space?	N/A
	Road X Slope (%)	1.9	N/A	Clear Space to XWalk (in)	N/A
N/A	Any Obstructions?	N/A	N/A	Storm Grate/Utility Hazard?	N/A
	Obstruction Type			Storm Grate/Utility Type	
		N/A			N/A
			Yes	Surface Condition? (G/P)	Good
			N/A	Curb Slope (%)	13.7

Possible Solutions:

Remove & Replace Curb Ramp With Two New Directional Ramps or Equivalent.

R304.3.2, R304.5.3
