Access Compliance Report

Public Rights-of-Way

(Curb Ramps)

| Intersection ID: 11978 | Main Street: WILSON_AV | Cross Street: BEAUX_ST | Location: S |

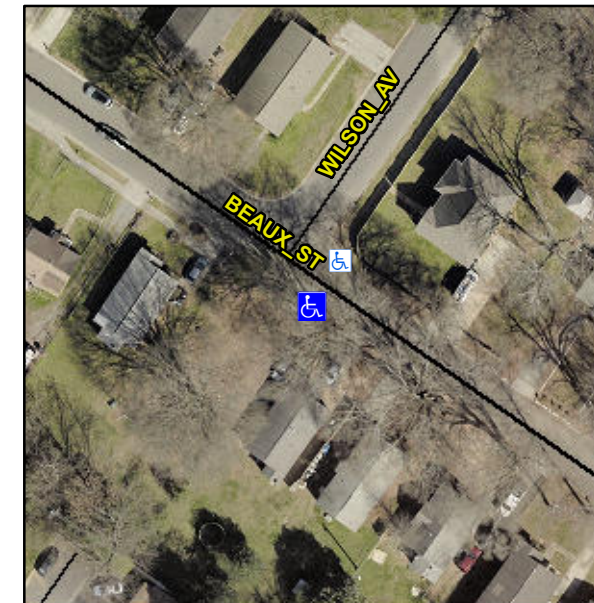
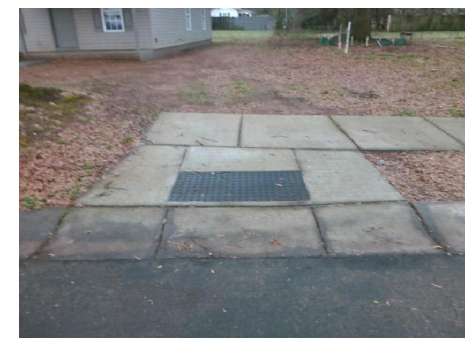
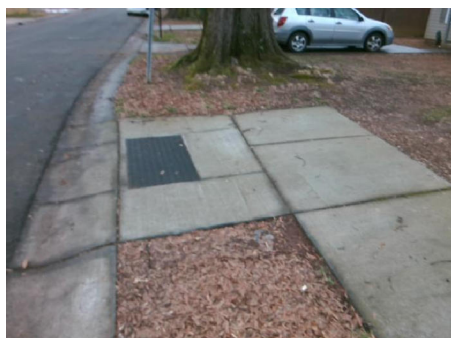
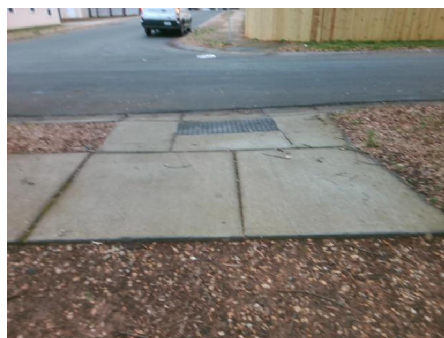
| ADA ID: 5CA435EA3610 | Ramp Type: BlendTrans1 | Initial Pass/Fail: Fail | Overall Compliance: No |
| | | Severity Score: 8.75 | |

Not Found, R304.5.1

| Compliance | Description | Data | Compliance | Description | Data |
|---|---|---|---|---|---|
| No | Ramp Width (in) | 47.0 | Yes | BlendTrans XSlope (%) | 1.7 |
| | | | No | Curb Slope (%) | 12.1 |

Remove & Replace Curb Ramp With Two New Directional Ramps or Equivalent.

Total Cost: \$ 3200.00
