Access Compliance Report

Public Rights-of-Way

(Curb Ramps)

Intersection ID: 10020374	Main Street: BALLANTYNE CORPORATE PL	Cross Street: N/A	Location:	E
ADA ID: 5CA4F7D5D6FE	Ramp Type: Perp	Initial Pass/Fail: Pass	Overall Compliance: No	Severity Score: 0.25
Codes/Mitigation Info/Possible Solution		Field Measurements/Component Compliance

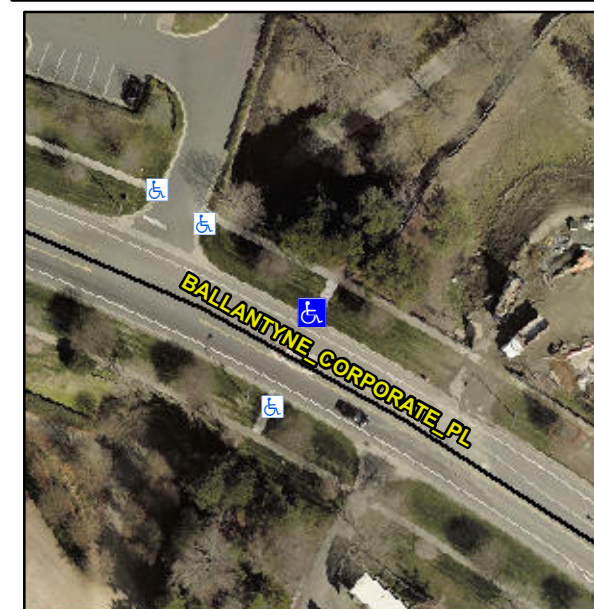
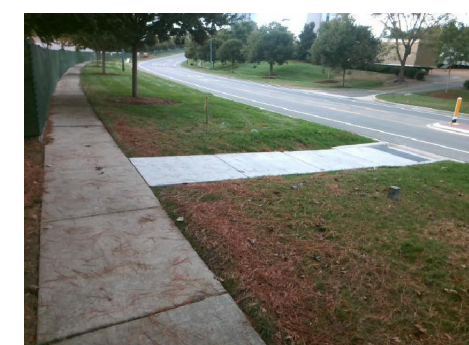
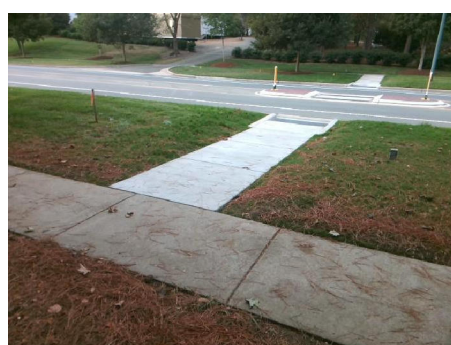
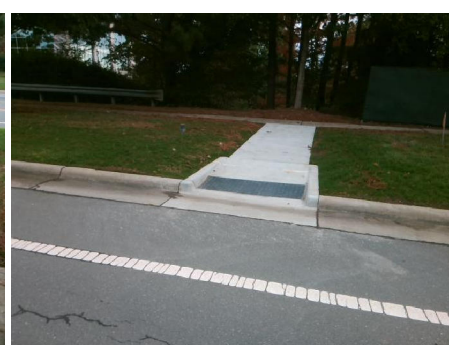
Not Found, R304.5.3, R304.2.2-Perp, R304.3.2-Para

Compliance	Description	Data	Compliance	Description	Data
N/A	Ramp Length (in)	72.0	Yes	Ramp Slope (%)	7.0
Yes	Ramp Width (in)	60.0	No	Ramp XSlope (%)	3.2
Yes	Flare Type L	Curbed_NoWalkSurface	Yes	Flare Type RT	N/A
Yes	Flare Slope LT (%)	N/A	N/A	Flare Slope RT (%)	N/A
N/A	Flare Traversable LT?	No	N/A	Flare Traversable RT?	No
Yes	Landing Length (in)	61.5	Yes	DWS Provided?	Yes
Yes	Landing Width (in)	60.0	Yes	DWS Contrast?	Yes
No	Landing Slope (%)	4.3	Yes	DWS Length (in)	24.0
Yes	Landing X Slope (%)	1.1	Yes	DWS Full Width?	Yes
N/A	Landing Curb? (Y/N)	No	Yes	DWS Offset (in)	0.0
N/A	Shared Landing?	No			
Yes	Gutter Ponding?	No	Yes	Gutter Slope (%)	1.5
Yes	Gutter Lip Ht (in)	0.0	Yes	Gutter X Slope (%)	1.2
N/A	Painted X Walk1?	No	N/A	Painted X Walk2?	N/A
	X Walk 1 Direction	To SW		X Walk 2 Direction	N/A
N/A	X Walk 1 Width (in)	N/A	N/A	X Walk 2 Width (in)	N/A
	X Walk 1 Slope (%)	2.4		X Walk 2 Slope (%)	N/A
	X Walk 1 X Slope (%)	2.0		X Walk 2 X Slope (%)	N/A

N/A	Ramp inside XWalk1?	N/A	N/A	Ramp inside XWalk2?	N/A
	Road Slope (%)	N/A	N/A	Clear Space?	Yes
	Road X Slope (%)	N/A	N/A	Clear Space to XWalk (in)	N/A
Yes	Any Obstructions?	No	Yes	Storm Grate/Utility Hazard?	No
	Obstruction Type			Storm Grate/Utility Type	
		N/A			N/A
			Yes	Surface Condition? (G/P)	Good

Possible Solutions:

Remove & Replace Entire Ramp.
