Access Compliance Report Public Rights-of-Way (Curb Ramps)

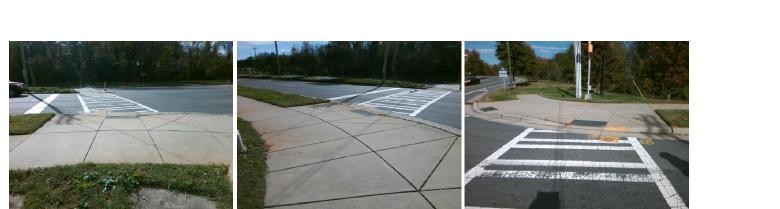
ntereastion ID: 51572 Main Street: EREEDOM DD				Cross Street, WESLEY, VIII LACE, DD				Location	NE
Intersection ID: 51572	Main Street: FREEDOM_DR			Cross Street: WESLEY_VILLAGE_RD				Location:	
ADA ID: 5CB765AD3D86	: 5CB765AD3D86 Ramp Type: Perp		Initial Pass/Fail: Fail Overall Compliance: No				o Severity Score:	10	
Codes/Mitigation Info/Possible Solution			Field Measurements/Component Compliance						
	SPA M	Possible Solutions:	Compliance Description			Data	Data Compliance Description		Data
and the second sec		Remove & Replace Entire Ramp		N/A	Ramp Length (in)	96.5	Yes	Ramp Slope (%)	6.8
e e e e e e e e e e e e e e e e e e e	A ARA			No	Ramp Width (in)	47.5	No	Ramp XSlope (%)	2.1
				N/A	Flare Type LT	N/A	N/A	Flare Type RT	N/A
S S S				N/A	Flare Slope LT (%)	N/A	N/A	Flare Slope RT (%)	N/A
E .				N/A	Flare Traversable LT?	N/A	N/A	Flare Traversable RT?	N/A
		¹		N/A	Landing Length (in)	N/A	N/A	DWS Provided?	N/A

L C. To Date L	1 Sector	Surveyor Notes:		N/A	Landing Width (in)	N/A	N/A	DWS Contrast?	N/A
	197	N/A		N/A	Landing Slope (%)	N/A	N/A	DWS Length (in)	N/A
				N/A	Landing X Slope (%)	N/A	N/A	DWS Full Width?	N/A
				N/A	Landing Curb? (Y/N)	N/A	N/A	DWS Offset (in)	N/A
NODERNA		9		N/A	Shared Landing?	N/A			
A A A A A A A A A A A A A A A A A A A		PROW/ADA:		N/A	Gutter Ponding?	N/A	N/A	Gutter Slope (%)	N/A
	-2-	Not Found, R304.5.1, R304.5.3		N/A	Gutter Lip Ht (in)	N/A	N/A	Gutter X Slope (%)	N/A
A A A A A A A A A A A A A A A A A A A		·····, ····		N/A	Painted X Walk1?	Yes	N/A	Painted X Walk2?	N/A
A CALL AND A					X Walk 1 Direction	To SW		X Walk 2 Direction	N/A
A stand and a second			N/A	X Walk 1 Width (in)	104.0	N/A	X Walk 2 Width (in)	N/A	
Street 1 Name FR	EEDOM DR	_			X Walk 1 Slope (%)	2.2		X Walk 2 Slope (%)	N/A
Stop Condition-Street 2	Signal				X Walk 1 X Slope (%)	0.2		X Walk 2 X Slope (%)	N/A
Street 2 Name	N/A			N/A	Ramp inside XWalk1?	Yes	N/A	Ramp inside XWalk2?	N/A

Stop Condition-Street 1	N/A				Road Slope (%)	N/A	N/A	Clear Space?	N/A
					Road X Slope (%)	N/A	N/A	Clear Space to XWalk (in)	N/A
				N/A	Any Obstructions?	N/A	N/A	Storm Grate/Utility Hazard?	N/A
		Total Cost: \$	1850.00		Obstruction Type			Storm Grate/Utility Type	
						N/A			N/A
