Access Compliance Report

Public Rights-of-Way

(Curb Ramps)

Intersection ID: 12629	Main Street: E_6TH_ST	Cross Street: N_DAVIDSON_ST	Location: E
ADA ID: 5CBBF489D2CD	Ramp Type: PerpDiag	Initial Pass/Fail: Fail	Overall Compliance: No
		Severity Score: 55

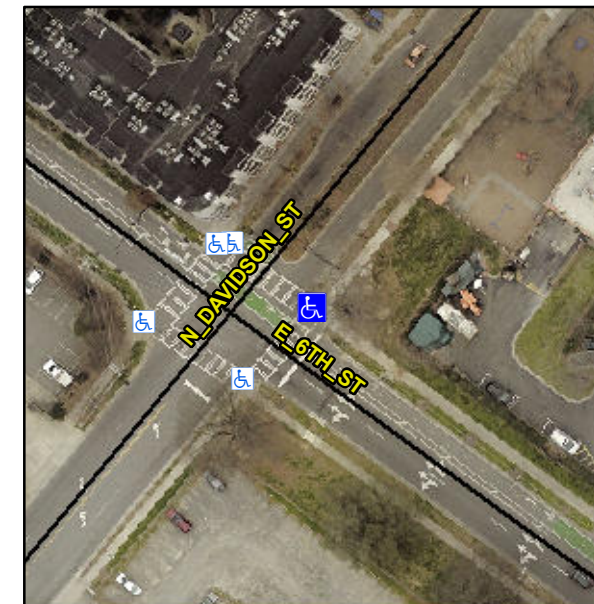
Not Found, R304.5.1, R304.2.2, R304.5.3

Compliance	Description	Data	Compliance	Description	Data
N/A	Ramp Length (in)	92.0	No	Ramp Slope (%)	9.0
No	Ramp Width (in)	32.0	No	Ramp XSlope (%)	7.7
N/A	Flare Type LT	N/A	N/A	Flare Type RT	N/A
N/A	Flare Slope LT (%)	N/A	N/A	Flare Slope RT (%)	N/A
N/A	Flare Traversable LT?	N/A	N/A	Flare Traversable RT?	N/A
N/A	Landing Length (in)	N/A	N/A	DWS Provided?	N/A
N/A	Landing Width (in)	N/A	N/A	DWS Contrast?	N/A
N/A	Landing Slope (%)	N/A	N/A	DWS Length (in)	N/A
N/A	Landing X Slope (%)	N/A	N/A	DWS Full Width?	N/A
N/A	Landing Curb? (Y/N)	N/A	N/A	DWS Offset (in)	N/A
N/A	Shared Landing?	N/A			
N/A	Gutter Ponding?	N/A	N/A	Gutter Slope (%)	N/A
N/A	Gutter Lip Ht (in)	0.5	N/A	Gutter X Slope (%)	N/A
N/A	Painted X Walk1?	Yes	N/A	Painted X Walk2?	Yes
	X Walk 1 Direction	To NW		X Walk 2 Direction	To SW
N/A	X Walk 1 Width (in)	105.0	N/A	X Walk 2 Width (in)	106.0
	X Walk 1 Slope (%)	8.4		X Walk 2 Slope (%)	0.5
	X Walk 1 X Slope (%)	2.1		X Walk 2 X Slope (%)	6.7

N/A	Ramp inside XWalk1?	Yes	N/A	Ramp inside XWalk2?	Yes
	Road Slope (%)	6.8	N/A	Clear Space?	N/A
	Road X Slope (%)	8.2	N/A	Clear Space to XWalk (in)	N/A
N/A	Any Obstructions?	N/A	N/A	Storm Grate/Utility Hazard?	N/A
	Obstruction Type			Storm Grate/Utility Type	
		N/A			N/A
		Yes		Surface Condition? (G/P)	Good

Remove & Replace Curb Ramp With Two New Directional Ramps or Equivalent.
