Access Compliance Report

Public Rights-of-Way

(Curb Ramps)

Intersection ID: 28438	Main Street: JESSICA_PL	Cross Street: PROSPERITY_VILLAGE_DR	Location: SW
ADA ID: 5CC5A04B296A	Ramp Type: Perp	Initial Pass/Fail: Fail	Overall Compliance: No
			Severity Score: 33.75

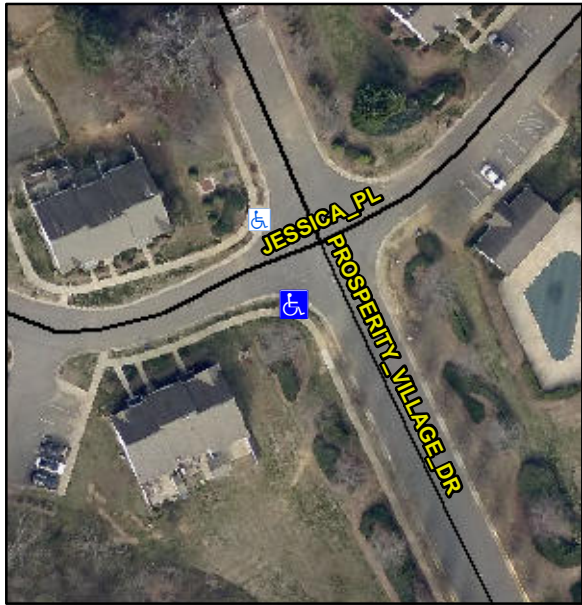
Possible Solutions:		Compliance	Description	Data	Compliance	Description	Data
	Remove & Replace Entire Ramp.		N/A	Ramp Length (in)	90.0	No	Ramp Slope (%)	20.0
			No	Ramp Width (in)	46.5	Yes	Ramp XSlope (%)	2.0
			N/A	Flare Type LT	N/A	N/A	Flare Type RT	N/A
			N/A	Flare Slope LT (%)	N/A	N/A	Flare Slope RT (%)	N/A
			N/A	Flare Traversable LT?	N/A	N/A	Flare Traversable RT?	N/A
			N/A	Landing Length (in)	N/A	N/A	DWS Provided?	N/A
			N/A	Landing Width (in)	N/A	N/A	DWS Contrast?	N/A
			N/A	Landing Slope (%)	N/A	N/A	DWS Length (in)	N/A
			N/A	Landing X Slope (%)	N/A	N/A	DWS Full Width?	N/A
Surveyor Notes:			N/A	Landing Curb? (Y/N)	N/A	N/A	DWS Offset (in)	N/A
N/A			N/A	Shared Landing?	N/A			
PROW/ADA:			N/A	Gutter Ponding?	N/A	N/A	Gutter Slope (%)	N/A
R304.5.1, R304.2.2			N/A	Gutter Lip Ht (in)	N/A	N/A	Gutter X Slope (%)	N/A

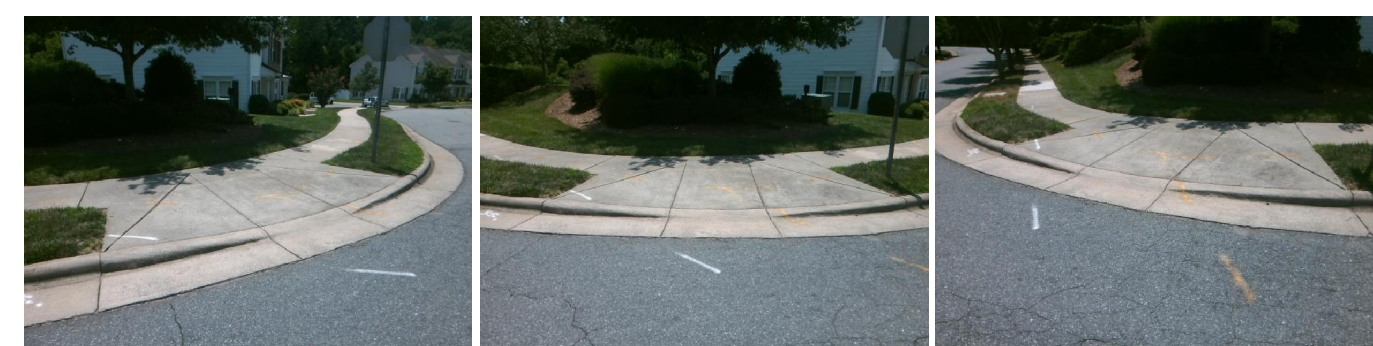
N/A	Painted X Walk1?	No	N/A	Painted X Walk2?	N/A
				X Walk 1 Direction	To N		X Walk 2 Direction	N/A
			N/A	X Walk 1 Width (in)	N/A	N/A	X Walk 2 Width (in)	N/A
				X Walk 1 Slope (%)	2.1		X Walk 2 Slope (%)	N/A
				X Walk 1 X Slope (%)	3.2		X Walk 2 X Slope (%)	N/A
			N/A	Ramp inside XWalk1?	N/A	N/A	Ramp inside XWalk2?	N/A
				Road Slope (%)	N/A	N/A	Clear Space?	N/A
				Road X Slope (%)	N/A	N/A	Clear Space to XWalk (in)	N/A
			N/A	Any Obstructions?	N/A	N/A	Storm Grate/Utility Hazard?	N/A
				Obstruction Type			Storm Grate/Utility Type	
						N/A		N/A
						Yes	Surface Condition? (G/P)	Good
Total Cost:		\$ 1850.00						
Street 1 Name		JESSICA PL						
Stop Condition-Street 2		StopSign						
Street 2 Name		N/A						
Stop Condition-Street 1		N/A
