Access Compliance Report

Public Rights-of-Way

(Curb Ramps)

Intersection ID: 12344	Main Street: REMOUNT_RD	Cross Street: GREENLAND_AV	Location: SE
ADA ID: 5CE1D4D804A9	Ramp Type: Perp	Initial Pass/Fail: Fail	Overall Compliance: No
		Severity Score: 8.75

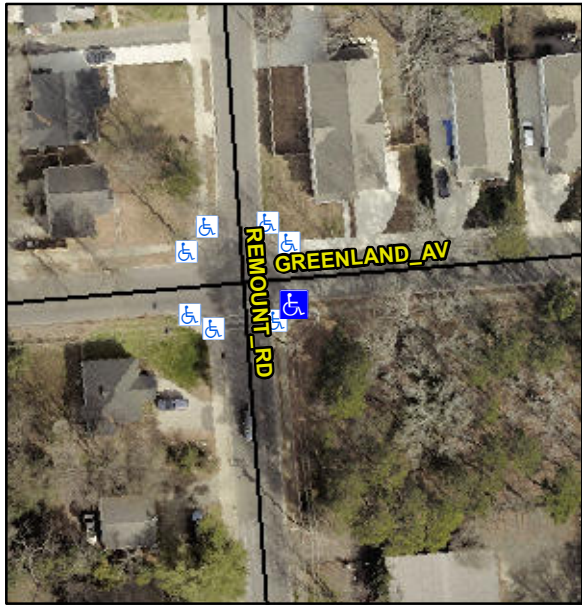
Possible Solutions:		Compliance	Description	Data	Compliance	Description	Data
	Remove & Replace Entire Ramp.		N/A	Ramp Length (in)	92.0	Yes	Ramp Slope (%)	6.2
			No	Ramp Width (in)	47.0	Yes	Ramp XSlope (%)	0.5
			N/A	Flare Type LT	N/A	N/A	Flare Type RT	N/A
			N/A	Flare Slope LT (%)	N/A	N/A	Flare Slope RT (%)	N/A
			N/A	Flare Traversable LT?	N/A	N/A	Flare Traversable RT?	N/A
			N/A	Landing Length (in)	N/A	N/A	DWS Provided?	N/A
			N/A	Landing Width (in)	N/A	N/A	DWS Contrast?	N/A
			N/A	Landing Slope (%)	N/A	N/A	DWS Length (in)	N/A
			N/A	Landing X Slope (%)	N/A	N/A	DWS Full Width?	N/A
Surveyor Notes:			N/A	Landing Curb? (Y/N)	N/A	N/A	DWS Offset (in)	N/A
PROW/ADA:			N/A	Shared Landing?	N/A			
Not Found, R304.5.1			N/A	Gutter Ponding?	N/A	N/A	Gutter Slope (%)	N/A
			N/A	Gutter Lip Ht (in)	N/A	N/A	Gutter X Slope (%)	N/A
